# Žirovac landslide: a case study of the local scale landslide investigation for engineering purposes with its assessment on a regional scale

Davor Marušić

**Abstract** A detailed analysis of the “Žirovac” landslide on Croatia’s state road section in the village of Žirovac is given in this case study. The landslide was triggered by the Petrinja earthquake in December 2020 and was subject to fast-paced processes of investigation and mitigation. The engineering geological and geotechnical survey including boreholes and geophysical investigations were performed on a large local scale.

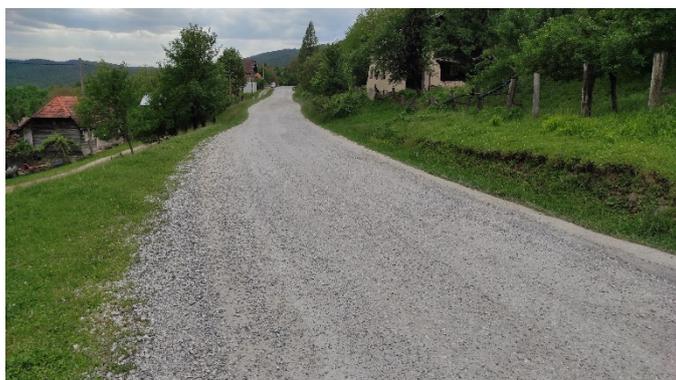
The earthquake-induced landslide event encompassed the body of the road in its full width along with the 2.5 m high road embankment. Shortly after the landslide event, to ensure traffic functionality, the unstable part of the landslide was covered with gravel material, forming a relatively denivelated but flat surface road. Such actions consequently covered most of the landslide body and part of the scarp and slip surface, limiting the ability to properly assess the landslide in terms of size.

Disregarding several potholes formed due to the embankment material's internal erosion, the newly formed gravel road section showed no signs of sliding in terms of tension cracks or other significant signs of landsliding. The landslide was evident on a general denivelation of the gravel road section, as well as on the partly covered main scarp which extended along part of the right (north) edge of the road as a shallow, 0.5-1.0 m cut under the natural slope.

According to the local information, the researched road section represents an occasional but persistent landslide, continuously covered with new layers of gravel material.

Figure 2. View towards the west on the unstable road section with the partly covered slide scarp along the northern edge of the road.

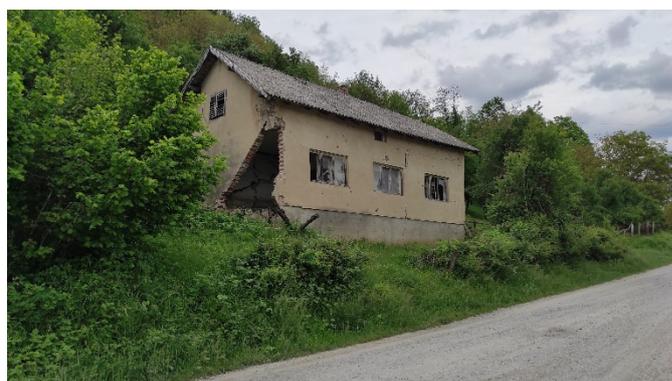
Most of the abandoned structures and present family houses on the wider slope area showed clear signs of differential subsidence, with many wide diagonal cracks on masonry walls, while almost every shallow construction on the slope (garden fences, paved infrastructure, wooden sheds, etc.) was partially dislocated or leaned.

Figure 3. Abandoned and highly damaged masonry building above the unstable road section.

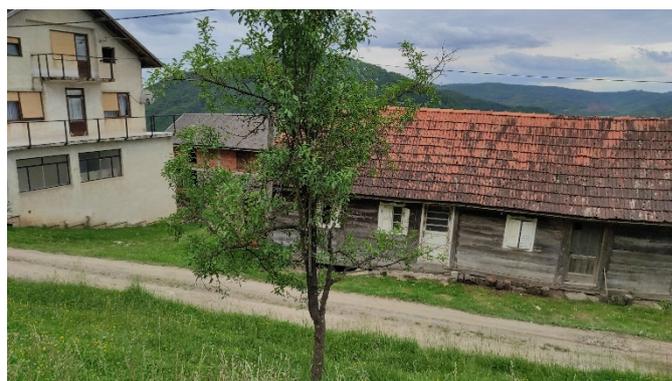
Figure 4. A damaged and leaned wooden shed below the unstable road embankment and an undamaged residential building with completely removed infrastructure.

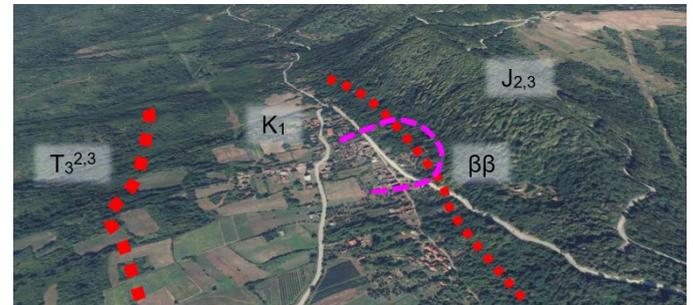
Figure 6. View on the geomorphological characteristics of the wider area with marked location of the global landslide (magenta dashed line) and frontal and secondary thrust (thick and thin red dashed line respectively); satellite map source (Google)

Considering the structural setting of the wider area, the main thrust area is characterized by a very small difference in slope inclination between the neighboring structural units represented with Cretaceous marls and limestones ( $K_1$ ) and Triassic dolomites ( $T_3^{2,3}$ ), where the dolomites governed area indicate a slight increase in slope steepness towards the south. The significant morphological difference is visible within the structural unit “Ophiolitic complex of Banija”, at the secondary thrust of the metamorphic and Jurassic formations ( $\beta\beta$ ,  $J_{2,3}$ ) on the Cretaceous sedimentary rocks ( $K_1$ ) where the more resistant, metamorphous, and sedimentary rocks form the hill “Vratnik”, while the weathered marls with limestones form the relatively slightly inclined area of the “Žirovac” village.

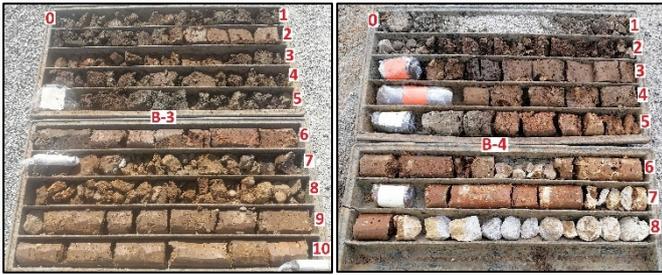
Bedrock layers are continuously covered by the deluvial/eluvial clay (younger) and clayey gravel (older), and the road embankment fill material. The thickness of the cover locally varies from 2.5-6.0 m in the central and eastern parts, with an increase to 7.0-9.5 m in the western part of the road section. This sequence can be observed on borehole cores in “Fig. 7”.

Figure 7. View of the relatively adjacent borehole cores with the cover material overlaying weathered marls at 8.0 m depth (borehole B-3) and limestones at 7.0 m depth (borehole B-4).

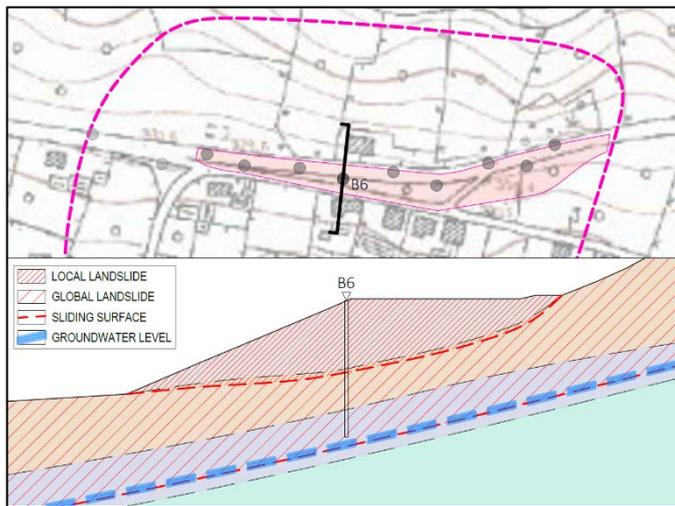
The local landslide represents the earthquake-induced landslide of the road embankment in its full width. The road embankment consists of up to 2.5 m thick clayey gravel filling material, overlaying the deluvial-eluvial clay and gravel cover and the deeper bedrock of weathered marls interbedded with limestone layers, situated approximately 2.5-7.0 m below the surface level.

Figure 9. Cross-section of the central part of the “Žirovac landslide” area with the road embankment overlaying the deluvial-eluvial cover (brown), and bedrock of limestones (purple) interbedded within marls (green); topographic map source (DGU)

The earthquake-induced sliding represents the embankment material rotational sliding along the upper cover – deluvial-eluvial clays. Although the sliding material mostly consists of gravel and boulders, the local landslide can be defined as a clay/silt rotational slide, due to the probable failure in the clay cover.

Regardless of the earthquake event, the sliding was also potentiated by the embankment material weight and the sliding surface geotechnical characteristics degradation from groundwater flow. According to the local information, local landslide represents an occasional but persistent landslide, continuously covered with new layers of gravel material.

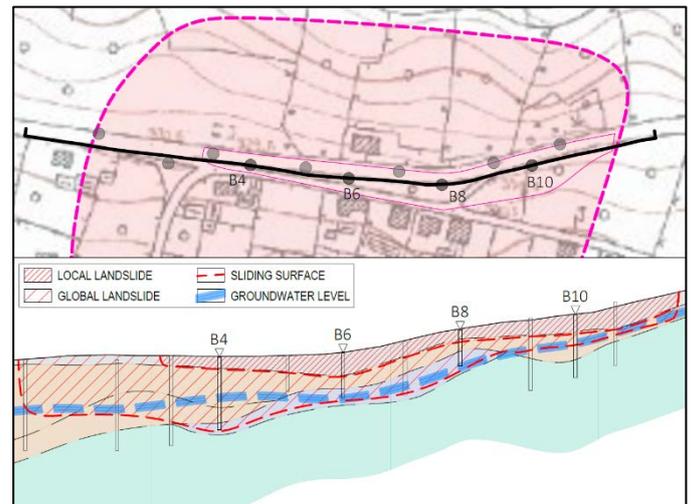
According to the research data, the global landslide is evaluated as the translational movement of the wider slope area with a sliding depth of 5.0-8.0 m below the road section.

Sliding material consists of both embankment material, and deluvial-eluvial cover, including the permeable limestone layer as an upper bedrock layer. This way the sliding surface of the limestone layer and the overlaying cover material is formed on a contact with weathered impermeable marls.

Figure 10. Frontal view of the “Žirovac landslide” along the embankment's southern edge with the surficial road embankment overlaying the deluvial-eluvial cover (brown), and bedrock of limestones (purple) interbedded within marls (green); topographic map source (DGU)

Although such a sliding mechanism could not be confirmed with the limited data acquired for the local landslide mitigation purposes, indications for the global landslide were significant, like the presence of the elongated depressions, bulges, and traces of smaller, overgrown secondary scarps perpendicular to the slope decline as well as the characteristic damages on the present constructions as shown in “Fig. 2” through “Fig. 4”. This was also confirmed by the local information, according to which the wider slope area represents a continuous, slow-moving landslide with high levels of groundwater during and shortly after the rainy periods.
