## Slope stability back analysis and a proposition for rehabilitation of landslide on the road section Gornji Milanovac – Klatičevo

**Abstract:** During the construction on the section of the designed road Gornji Milanovac - Klatičevo (Gornji Milanovac Bypass), in the period from November 2022 to April 2023, there was an occurrence of slope instability on the right side of road cut from km 0+910 to km 0+950 i.e., terrain sliding in the form of soil creep. A landslide occurred on the part of the constructed cut slope, which extends over a total length of approximately 125 m. The surface layer of soil affected by sliding (colluvium) is made of silty-sandy clay, soft to medium hard consistency and increased water content. This material was originally created by the decomposition of the basic rock mass (bedrock) and the deposition of material from the higher parts of the slope by planar erosion (diluvium). Bedrock under the diluvium layer consists of the Neogene (Miocene) complex of red sandstones. For the purposes of defining the natural conditions in the terrain under which the terrain sliding process was activated, a slope stability back analysis was performed for the Mohr-Coulomb

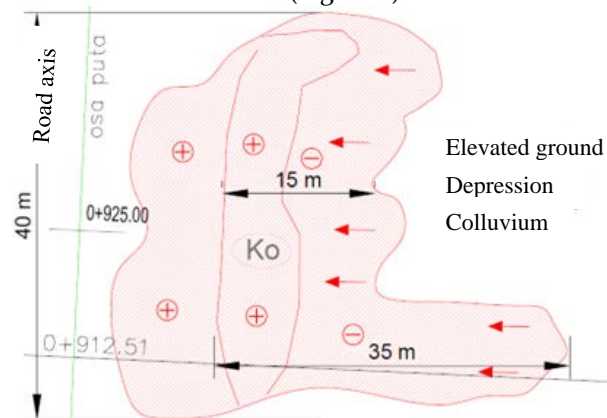
Figure 1. Situational plan of landslide from km 0+910 to km 0+950

The width of the landslide was about 40 m, and the length varied from 15 to 35 m (Figure 1). Taking into account the results of engineering geological mapping of the terrain and the results of previously performed research and tests, for the purposes of creating a project for a construction permit, an appropriate geotechnical model of the terrain with the position of the sliding plane was formed.

The instability of part of the slope occurred in the period november 2022 - april 2023. First, fissures and fractures appeared in the ground, and over time, a landslide occurred that gradually spread. The surface layer of deluvial clay (dl-gl) was affected by sliding to a depth of 1-3 m. The width of the landslide is about 40 m, and the length varies from 15 to 35 m.

It is recommended to rehabilitate the unstable slope by creating a support structure in the lower part of the landslide or by replacing the clay material in the part of the unstable slope. It is also recommended to protect the part of the slope that is stable with geogrids in order to prevent the eventual occurrence of instability on that part of the slope as well. The recommended values of geotechnical parameters required for stress-deformation analyzes and stability calculations, when developing a landslide rehabilitation project, are shown in table 1.

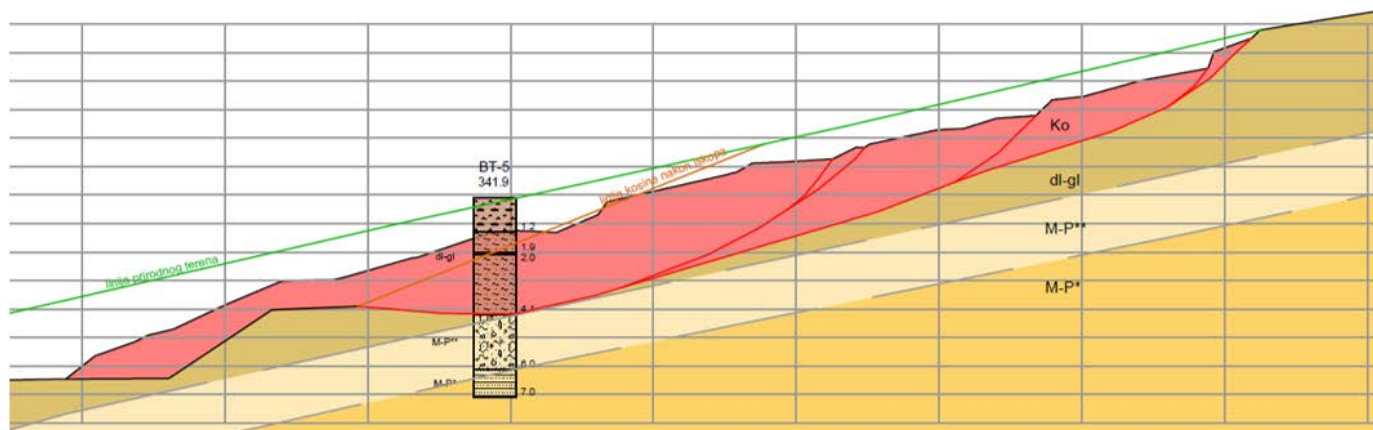
Figure 2. Engineering-geological cross section (km 0+912)

The main rock mass under the deluvium layer is built by the Neogene (Miocene) complex of red sandstones. It is characterized by great facies diversity. The rock mass is represented by red sandstones and siltstones, with varying degrees of fracturing and alteration. Gradually changing of harder, less degraded zones with zones of a higher degree of alteration is characteristic (Figure 2).

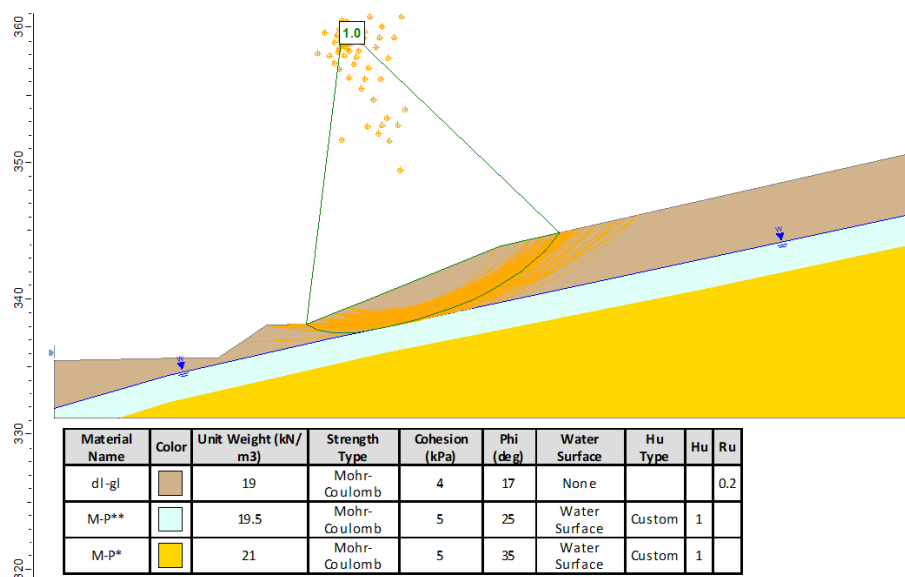
Figure 3. Slope stability back analysis (cross section on km 0+912)

Slope stability back analysis was done for the Mohr-Coulomb failure criterion and the state of effective stresses, where the value of unit weight  $\gamma=19.0 \text{ kN/m}^3$  was adopted. Stability calculations were done in the RocScience’s Slide software (Figure 3).

- Friction angle ( $\phi_m'$ ) = 17 °
- Cohesion ( $c_m'$ ) = 4 kPa

The mobilized strength represents the shear stress required to maintain the equilibrium of the sliding body. The parameters obtained by the back analysis are authoritative for the calculation of the effect of forces from the sliding body.

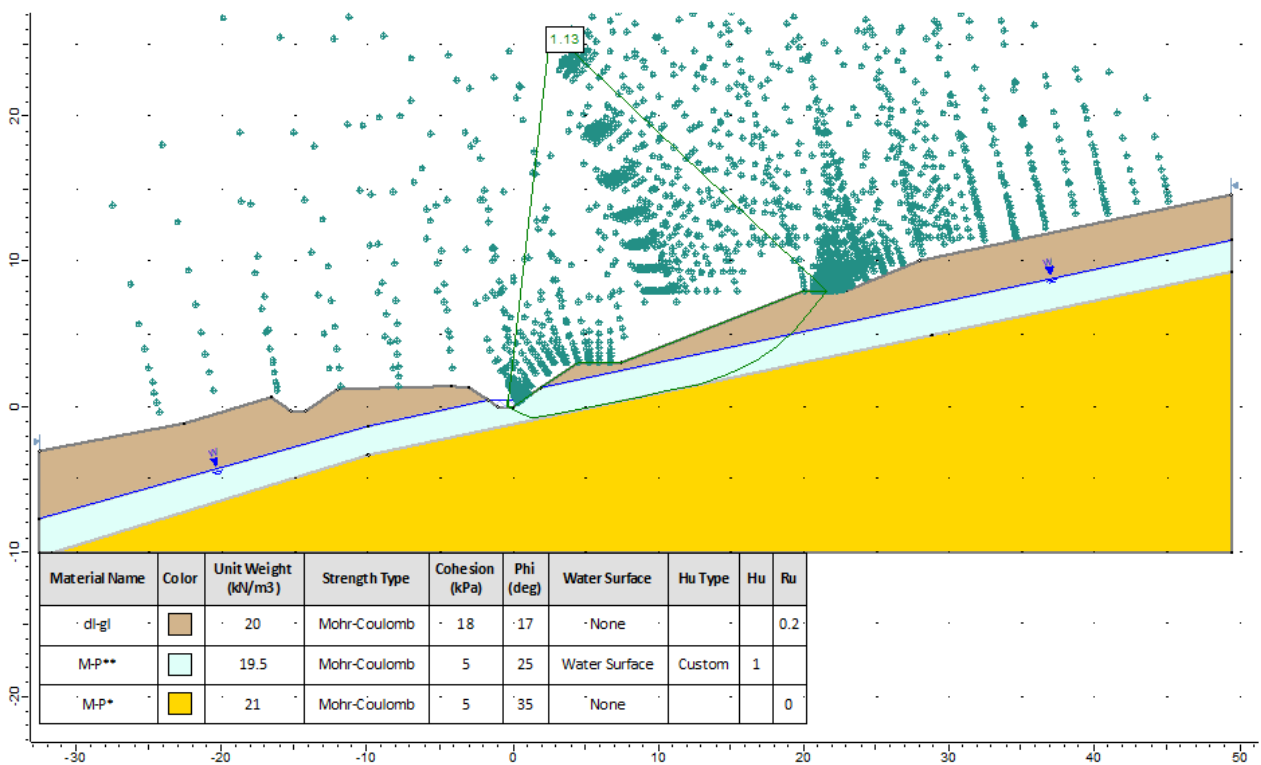
Figure 4. Cut stability analysis on km 0+650 (Geotechnical Report, CIP, 2022.)

Checking of the limit equilibrium of the cut slope was made according to SRPS EN 1997-1, using partial safety factors. Approach 3 was used, according to which partial factors were adopted for soil strength parameters: for the friction angle  $\gamma_{\phi}=1.25$  and for cohesion  $\gamma_c=1.25$ .

The incline of the slope is designed so that in the lower part of the slope the initial incline is 1:1.5 (33°) up to a height of 3 m, and the incline at a height of over 3 m is 1:2.5 (22°). The slope stability analysis was done with the influence of groundwater in order to simulate extreme conditions during exploitation. The influence of water was introduced into the calculation through the level of underground water in the layer of sandy clay debris (M-P\*\*) and the coefficient  $R_u=0.2$  in the layer of deluvial clay (dl-gl). The stability analysis was performed for the section at the chainage km 0+950, where the height of the slope was the highest (10.7 m) and a satisfactory safety factor was obtained ( $F_s=1.13$ ) (Figure 4). The required value of the minimum global safety factor in calculating according to the Eurocode is  $F_s>1$ .

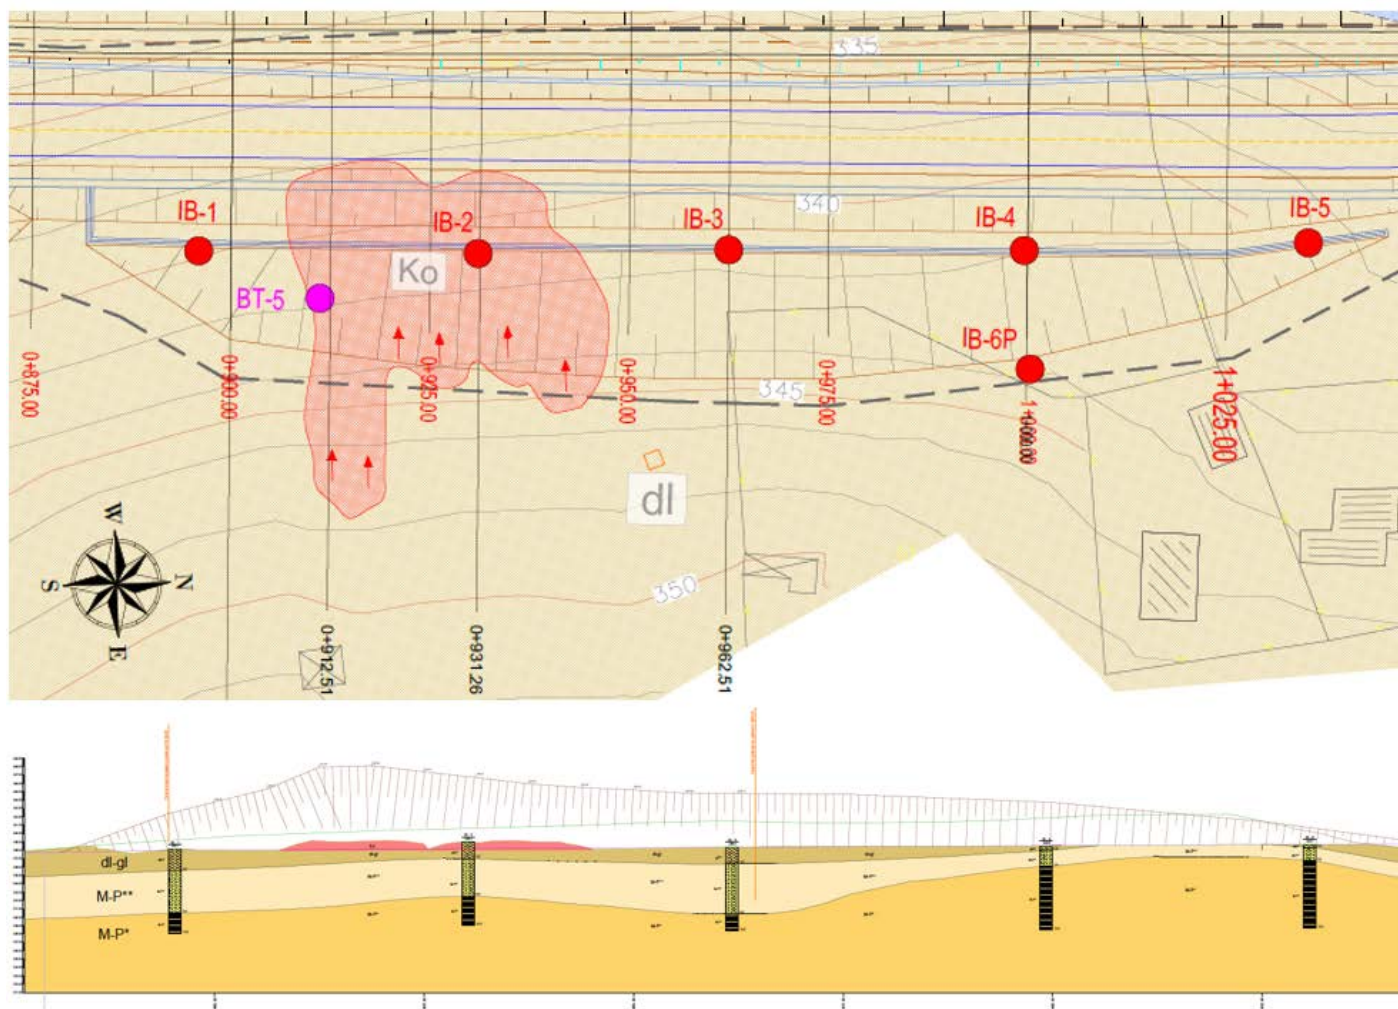
Figure 5. Engineering geological map with position of additional investigation works and an engineering geological section of terrain

Exploratory drilling was carried out on the subject slope from chainage km 0+850 to km 1+035. A total of 6 exploratory boreholes were drilled, 7.0 - 10.0 m deep, total drilling length 57.0 m (Figure 5). During the execution of the exploratory boreholes, engineering geological mapping of the core was carried out, i.e. identification and classification of lithological members (Figure 5).

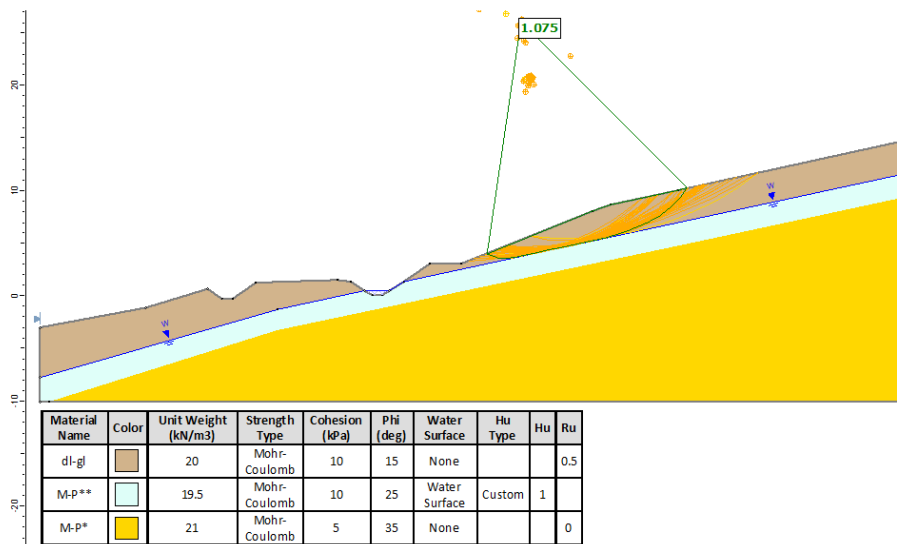
Figure 6. Cut slope analysis of the stability at km 0+950 with reduced soil strength parameters and complete saturation of the deluvial clay layer  $R_u=0.5$

In order to demonstrate that the occurrence of a landslide (unstable slope) could not be predicted during the design process, we reduced the soil strength parameter to values lower than the minimum obtained by laboratory tests. We also included in the calculation the maximum hydrostatic influence of groundwater in the clay layer. By lowering the strength parameters of the deluvial clay layer (dl-gl) with cohesion values  $c=10$  kPa and the friction angle  $\phi=17^\circ$ , as well as adopting the coefficient  $R_u=0.5$ , a satisfactory safety factor ( $F_s>1$ ) is obtained (Figure 6).

The stability analysis with reduced strength parameters shows that the occurrence of landslides could not be predicted because even with the adoption of significantly lower strength parameters than those obtained from laboratory tests (including parameters obtained from additional research), as well as the maximum hydrostatic influence in the deluvial clay layer, satisfactory factor of safety is obtained.
