Geotechnical Conditions, Stability Analysis and Remedial Measures of Višnjička 74 Landslide in Belgrade

Abstract This paper presents the results of geotechnical investigations, stability analysis and urgent remedial measures of the landslide at Višnjička 74 street in Belgrade. The area under study is located at the foot of an old fossil landslide. The landslide was activated due to excavation of the foundation pit in June 2023. Due to large displacements of the retaining structures and the surrounding objects, urgent remedial measures were proposed. Following these measures, further sliding was prevented. Additional geotechnical investigations were performed (geophysical investigations, inclinometer measurements, boreholes, soil sampling, laboratory tests, piezometers), to obtain more comprehensive insight into the processes responsible for sliding. Residual shear parameters were determined by laboratory tests, and back calculated using numerical analysis and inclinometer readings. Very complex geotechnical conditions were determined on-site and thus presented in the light of future construction works.

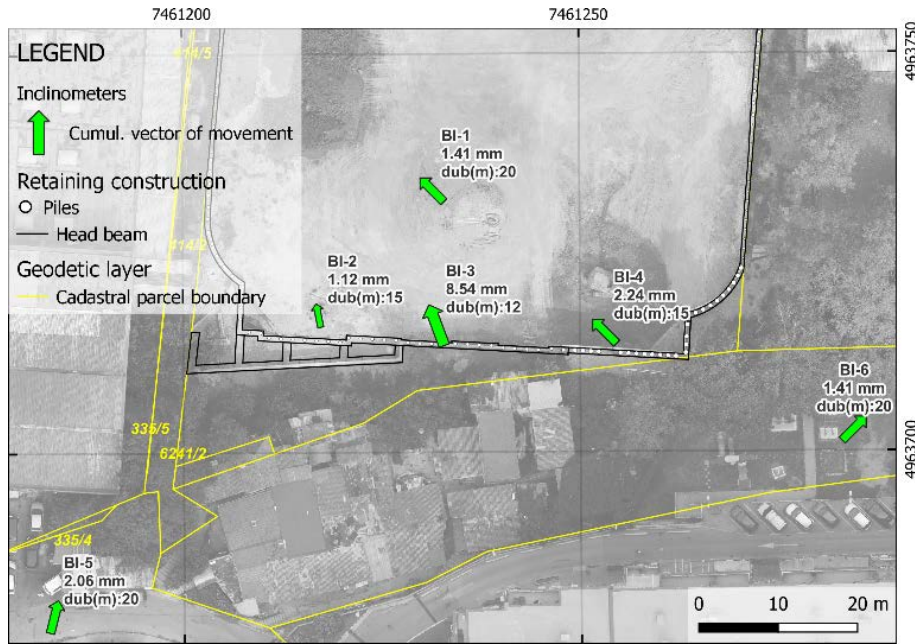
Figure 3. Vectors of maximum (cumulative) inclinometer displacements

Displacement values (> 2 mm) and landslide activity directions were recorded in inclinometers BI-3 (Figure 5) and BI-4 at depths of 12-15 m. Although the displacements near the precision limit (< 2 mm) were detected in inclinometers BI-1, BI-2, and BI-6, they cannot be disregarded, as their activity coincided temporally and occurred at similar depths as those in inclinometers BI-3 and BI-4. Clear determination of the depth and shape of the landslide surface was not feasible without additional inclinometer movements and prolonged monitoring, risking the stability of adjacent structures, particularly the residential business complex "Danube Terraces".

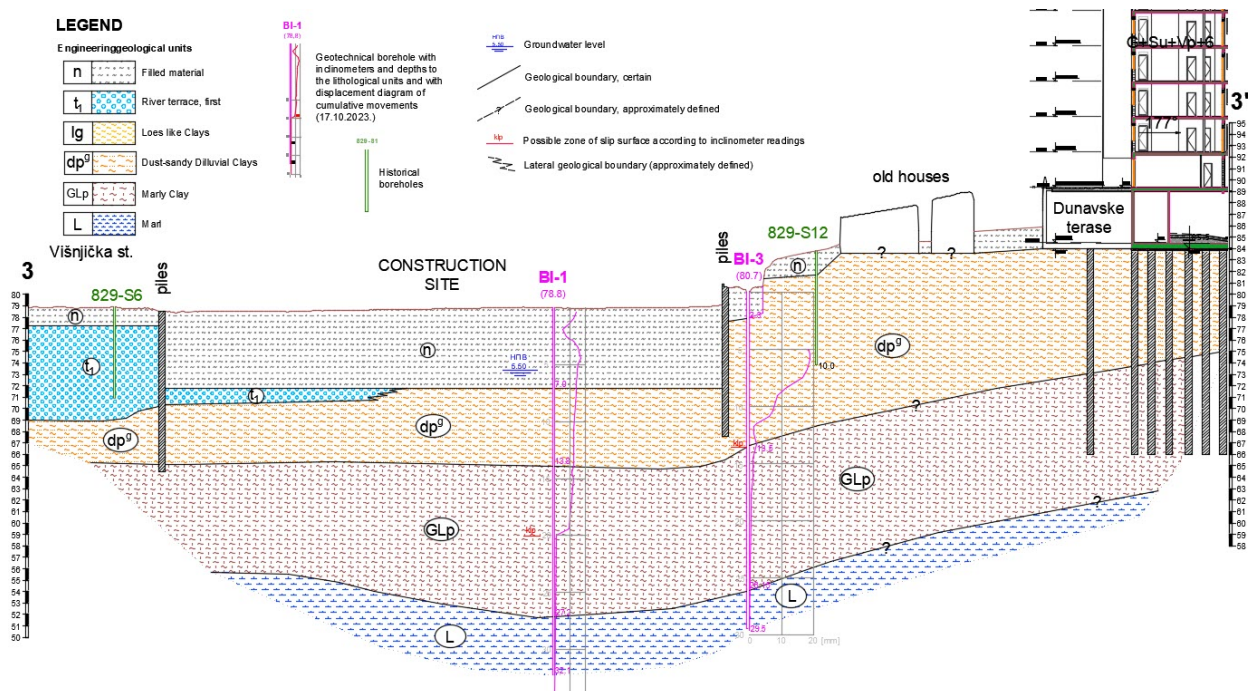
Figure 4. Geotechnical cross-section 3-3'

The ground investigations revealed a relatively high groundwater level (2 to 5 m below surface level, as shown in Figure 4), compared to the original excavation plan (up to 72 m above sea level), accompanied by occurrences of seepage and pressurized groundwater in soil fissures. A wet period from May to June 2023 coincided with excavation, leading to a rise in groundwater levels and unfavourable hydrological conditions. The hydrological state resulted in high pore pressures within the soil mass, contributing to the formation of deep sliding surfaces in the marly clays. These high pore pressures represent a significant geotechnical constraint for slope stability at the site location.

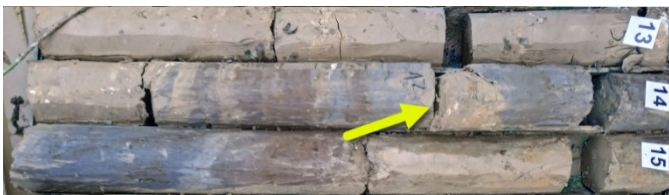
Figure 5. Photograph of BI-3 borehole core log in the zone of the slip surface (yellow arrow)

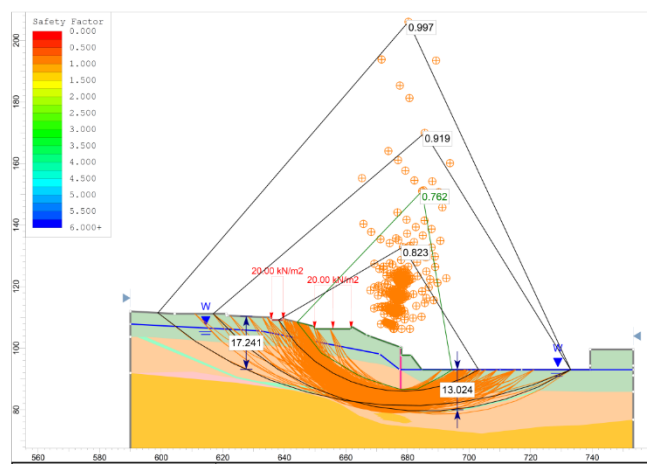
Obtained results show that complete foundation pit excavation, as well as controlled excavation, leads to a factor of safety lower than 1, which is in line with the field observations and inclinometer readings. Also, surrounding objects are in the zone of critical sliding surfaces. With an unexcavated foundation pit, factors of safety range between 1.2-1.5, which is considered acceptable. Therefore, an alternative design solution with a shallow mat foundation is checked, and this scenario leads to the factors of safety 1.18-1.4, which is considered acceptable.

Figure 6. The factor of safety for complete foundation pit excavation (with berms), according to the original design (section 1-1). Both assumed sliding surfaces are critical

As previously shown, foundation pit excavation would lead to a large movement of a landslide. Therefore, to proceed with an excavation, the very expensive retaining structure must be constructed first. Due to high costs, an alternative solution without underground floors is adopted. First, the shallow mat foundation is considered. However, due to the urgent and uncontrolled filling of the foundation pit, a very soft and thick (6-8 m) fill was formed, which made the shallow foundations impossible to construct. Estimated settlements of the shallow foundations on fill are in the range of 30-40 cm, which is considered unacceptable.

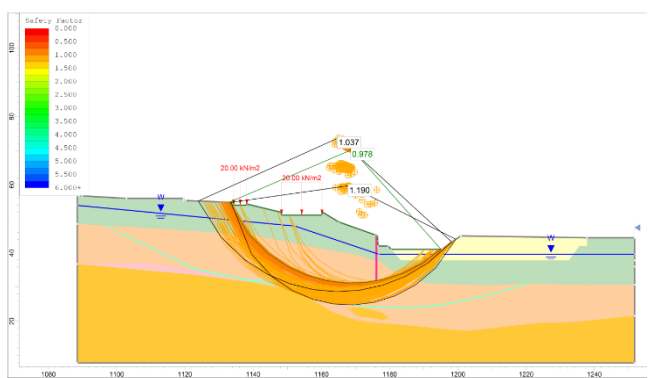
Figure 7. Factor of safety for controlled excavation to "trigger" reactivation of the previously stabilized landslide (section 1-1). Factor of safety ~1.0
