Failure estimation of the Majdanpek open pit east face based on inverse velocity model

Miloš Marjanović⁽¹⁾, Stefan Milanović⁽¹⁾, Nikola Simić⁽¹⁾, Lazar Kričak⁽¹⁾

1) University of Belgrade, Faculty of Mining and Geology, Belgrade, Djusina 7, milos.marjanovic@rgf.bg.ac.rs

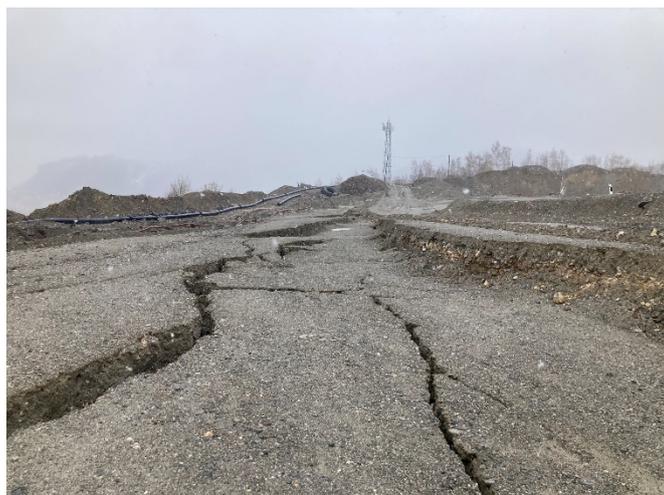
Figure 2 Gaping cracks and local benching between conjugated failure planes on the abandoned tailing horizon 550 m.

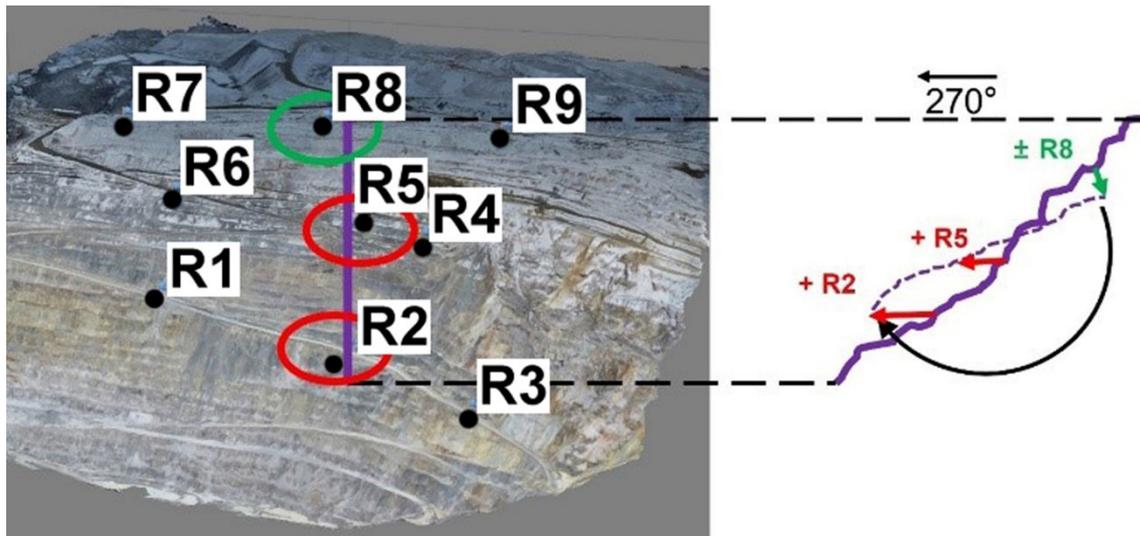
Figure 4 Schematic display of global rotational failure based on initial benchmark measurements.

Initially, during the first month of the survey, the lower benchmarks R1-3 showed indications of more dominant horizontal component vs. vertical displacement (~30 mm/day vs. ~10 mm/day, respectively), whereas the topmost benchmarks showed twice larger vertical displacements than horizontal (~20 mm/day vs. ~10 mm/day, respectively). This is an indication for global rotational slip, which has been further measured (Fig. 5). After this period, in March 2023 the lower benchmarks were destroyed and became inaccessible, partly due to regular mine operations, but partly due to deformations.

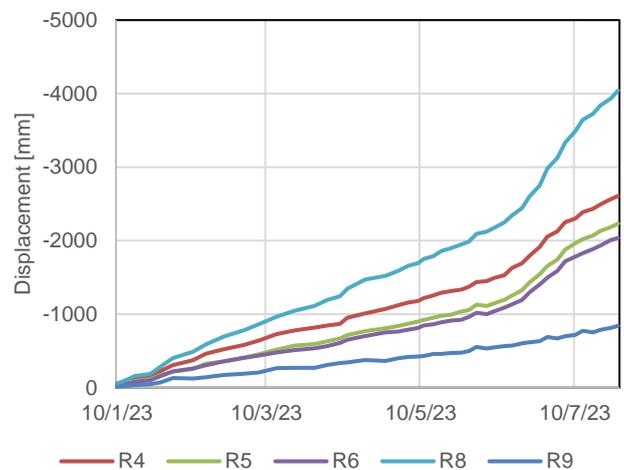
Cumulative displacement suggests that there are periods of acceleration and deceleration, which are synchronized across all benchmarks (Fig. 5), indicating that global failure is possible, and that inelastic creep is in progress. Displacement rate is the highest in benchmark R8, reaching 60 mm/day. Smaller accelerations were obvious in Jan-Feb (ranging between 10-20 mm/day), and Apr-May (ranging between 20-30 mm/day), while the most prominent one is in Jun-July (ranging between 30-40 mm/day). In between, the displacement rate is constant at about 5-10 mm/day. Such rate corresponds to Slow to Moderate landslides according to conventional classification (Hungri et al., 2014), while in domestic mining legislation they can be considered level 4 of 5, which is an alerted stage, just before immediate actions.

Despite the heavy rainfall which was often in first part of the 2023, causing flooding in the Pek River area. there was no direct correlation of these accelerations with the rainfall. as R² value was as low as 0.3. Mining activities were also uncorrelated, due to simultaneous unloading of the lower horizons and loading of the upper ones. In addition, the unloading was undertaken on the in the upper horizons comprising of the tailing material, to prevent local failures.

Figure 5. Cumulative vertical displacement for Jan-Jul 2023 on benchmarks R4-9.

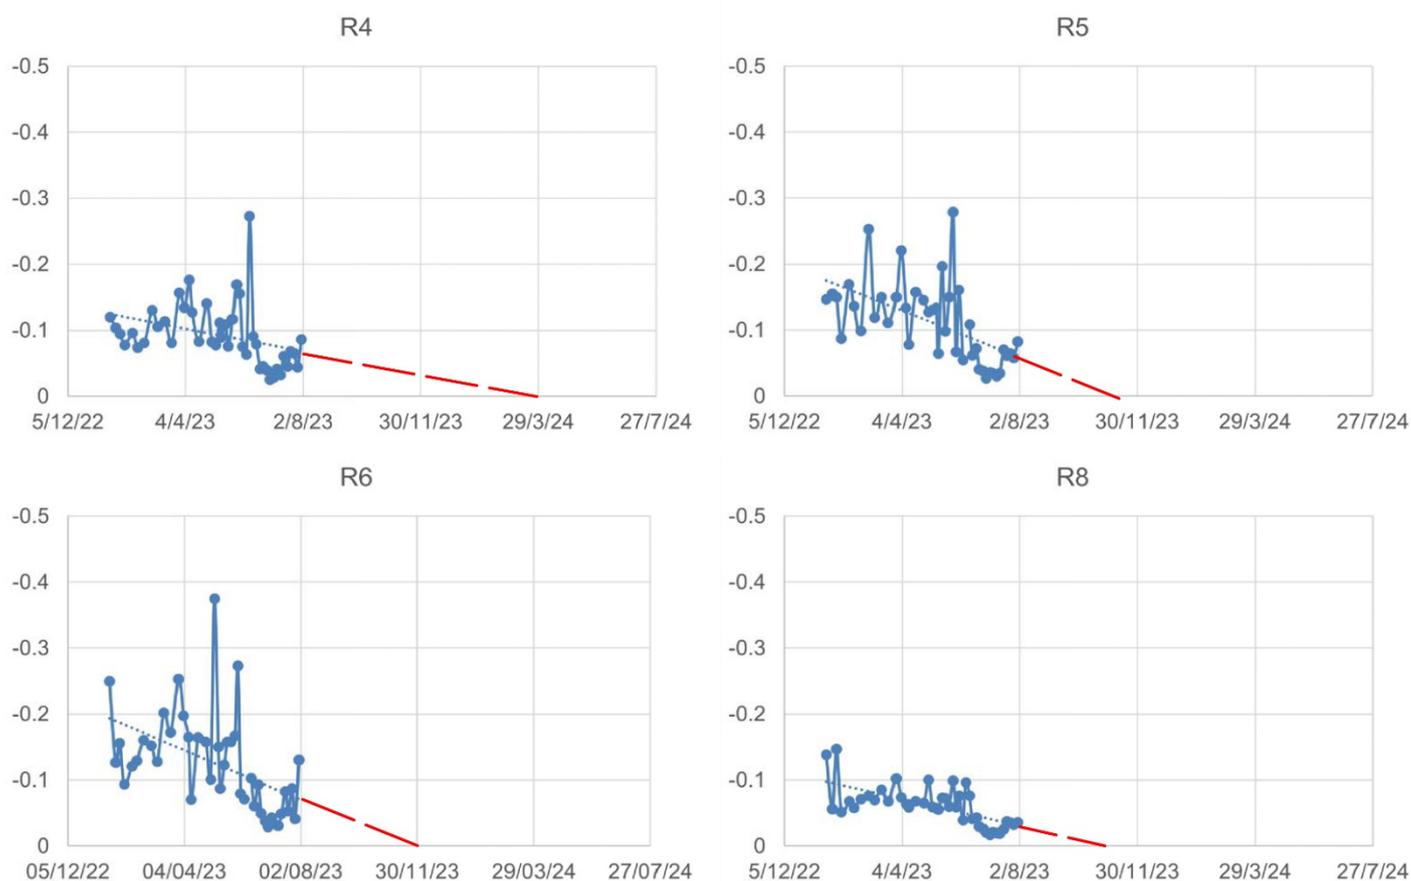
Displacement rates are calculated for Northing, Easting and Z directions and total vector. Given the slope orientation, the total horizontal vector more-or-less coincides with westward movement. Therefore, the most interesting are findings for -Y and -Z (vertical) directions. The inverse velocity linear trends (Fig. 6) are suggesting that the creep is still not in the final acceleration phase, as the trend gently declines towards the horizontal axis for all benchmarks. Benchmark R9 is showing biased values as it has both uplift and subsiding, so its general trend is parallel to horizontal axis. In other words, there are no accelerations and decelerations at R9 position, and its overall displacement rate is minor in comparison to other benchmarks, which is also apparent from the cumulative plot (Fig. 5). For this reason, R9 is not visualized in Fig. 6.

All linear trends are calculated using least square method. Their linear extrapolations (Fig. 6) are not ideally aligned, but all indicate failure by the end of 2023 or beginning of 2024.

Figure 6 Inverse velocity plots of vertical displacements and extrapolated time of failure (red dashes).

As the immediate measures were undertaken to prevent further displacement acceleration (including reshaping of the slope geometry and draining), this pessimistic estimation was luckily never confirmed, although it remains a big question whether the failure would follow the estimated linear trend or curve back upward and decelerate to a new steady state, as previously seen in some examples (Carlà et al., 2018). It is likely that a simple creep mechanism cannot entirely approximate the behaviour of a large rock slope, and that other complexities and additional factors were more influential than anticipated.
