The Role of Research, Conservation-Restoration Treatments and Presentation of Monuments for World Heritage Sites

Case study – Medieval Church of St. Michael in the Old Town of Kotor

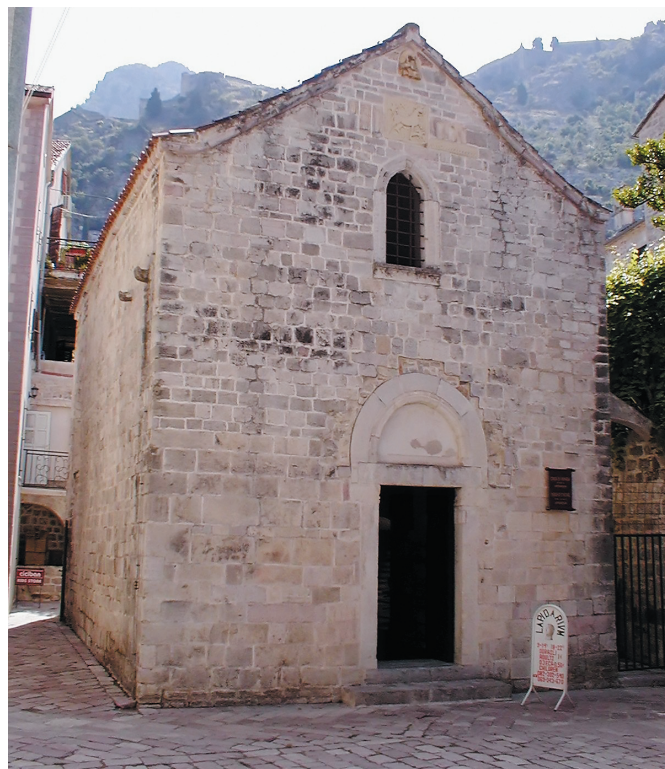
Fig. 4 Church of St. Michael – after the works

Architectural research of the church of St. Michael were started with technical recordings of the entire building, plastering in the interior and sounding research of walled openings. Prior to these works, the found mezzanine wooden structure was removed, except in the eastern and western parts, where it served as a support for the support structure of the damaged vaults. At the same time, an inspection of the surfaces under the frescoes in the apse and on the east wall, which Cvito Fisković wrote about in the 1950s, was carried out from the platform at the height of the mezzanine structures. At that time, the frescoes could be seen under the peeling lime coatings, and the wall paintings remained in this condition until the April 1979 earthquake. On the west side, the same platform was used to view the bricked-up window of the broken arch (fig. 1–4).

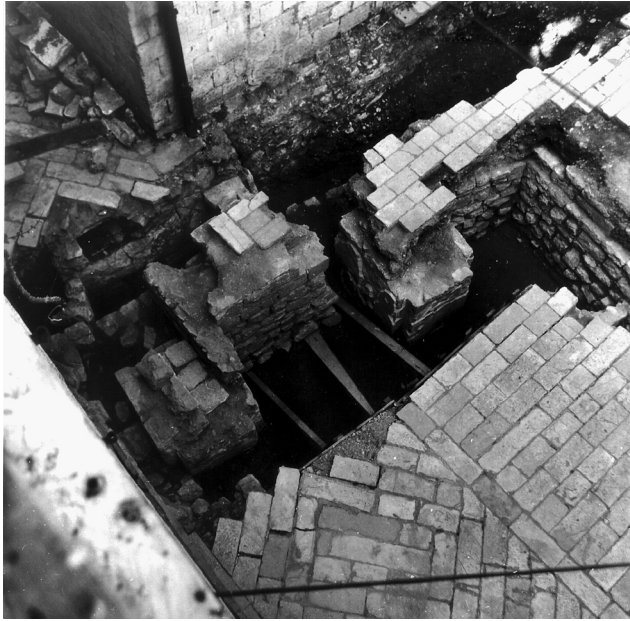
Fig. 7 Archaeological probe on the square, south side

Archaeological research conducted inside the church of St. Michael, in the square on its western side, in the area east of the apse, as well as in the passage on the southern side, were aimed at verifying the assumption of the existence of an older church of St. Michael in this place. Namely, in the document on the consecration of the cathedral of St. Tryphon in Kotor, among the church dignitaries present, “abbot Peter St. Michael of Kotor“ was also mentioned.⁹ Since the present-day church of the same name with Romanesque-Gothic stylistic features could not be mentioned in the document from 1166, it was assumed that the church of Abbot Peter could have stood in the same place, that is, in the foundation zone of the present-day church. Archaeological research undertaken in 1982/83 and in 1988/89, as well as in 2000, showed that, in the foundation area of the present church, there are two older successively built temples (fig. 5–8).

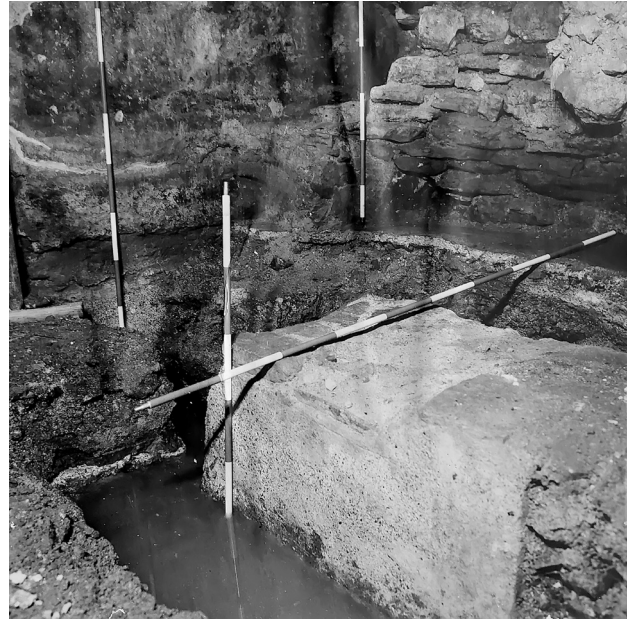
Fig. 8 Space in the apse, column of the altar canteen

The plaster on the surfaces of the masonry column of the altar canteen, which descends significantly lower than the level of the floor in the altar apse, indicates the need for further research that will enable a closer understanding of the appearance of the foundation of the oldest church building below the church of St. Michael. Its remains are located in the zone of permanent underground water as well as in the conditions of the densely built city fabric of Kotor, which until today limited the possibility of further archaeological excavations. For these reasons, it was not possible to verify whether the original church from the early Christian period had a three-nave foundation as assumed.

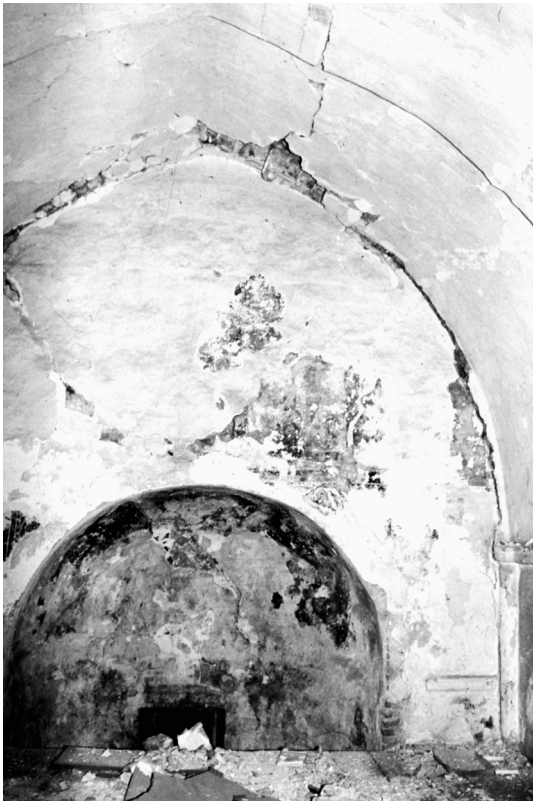
Fig. 9 Interior of the church, view of the eastern wall before painting and conservation research

St. Michael, it is evident that the other wall surfaces belonging to the same phase were not painted, which can be concluded from the appearance of the plastered columns that do not have wall paintings (fig. 9–10).

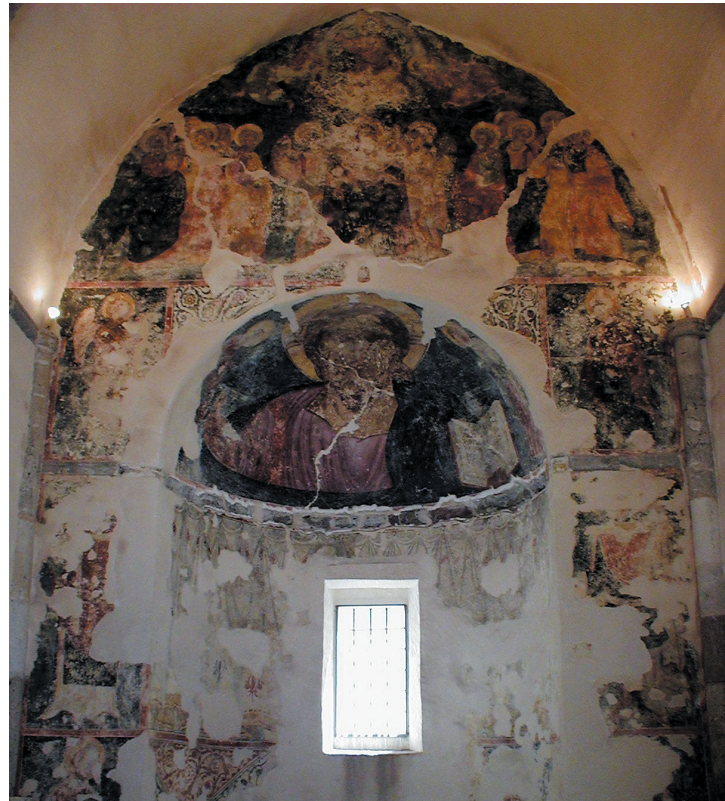
Fig. 10 View of the eastern wall and the apse, after the finished painting and conservation works

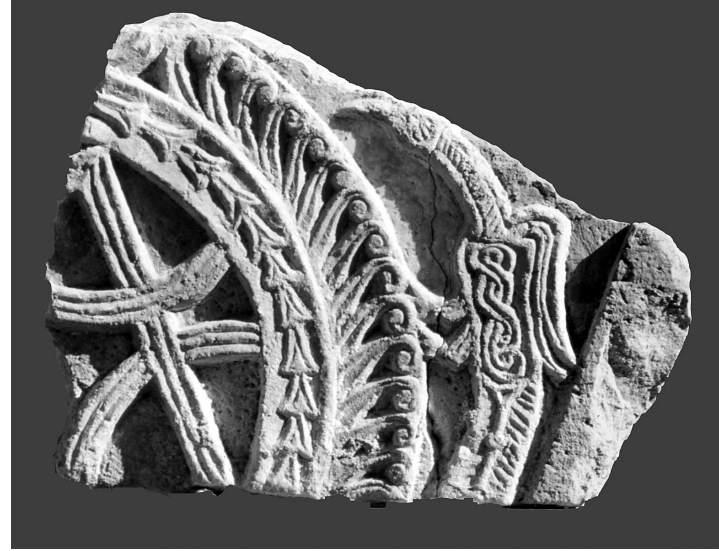
Fig. 11

Fragment of a pluteus with a circular motif and a representation of a bird

During the archaeological research carried out in the interior of the church of St. Michael and in the area of the square on its western side, numerous fragments of stone plastic decorated with relief motifs were discovered. Most of the fragments were found above the reddish plaster floor. Fragments of the altar partition with pre-Romanesque stylistic features were turned with the motif towards the floor and covered with sand in a layer of approx. 25 cm. The conditions in which this find was stored speaks of the sacral meaning that the space that preceded it had for the builders of the early Romanesque church, as well as the stone liturgical furniture from which the largest number of fragments originate. Apart from the fragments of the altar partition (plutes, pilasters, pillars of the architrave beams and the arched passage towards the altar space...), parts of windows, cornices and other architectural elements were found in the stone plastic inventory.

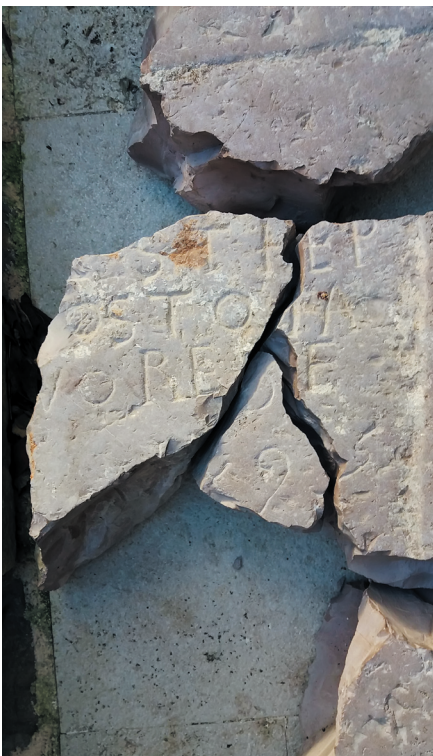
Fig. 13

Fragments of a tombstone with the commemoration of Stjepan Ostoja

A number of inscriptions can be found on tombstones that stood in the floor of the Roman-Gothic church. These inscriptions also contain information about the time of creation and the names of the people who had their tombs inside the church. Their memories in historical sources can shed light on the life of this church in the past, but also of the city of Kotor as a complex social creation.
