## POSSIBILITIES OF STAGED RENOVATION OF REINFORCED CONCRETE FACADES OF MULTI-FAMILY BUILDINGS IN THE CENTRAL ZONE OF NEW BELGRADE

KEYWORDS \_ *New Belgrade, reinforced concrete facades, façade renovation, multi-family housing*

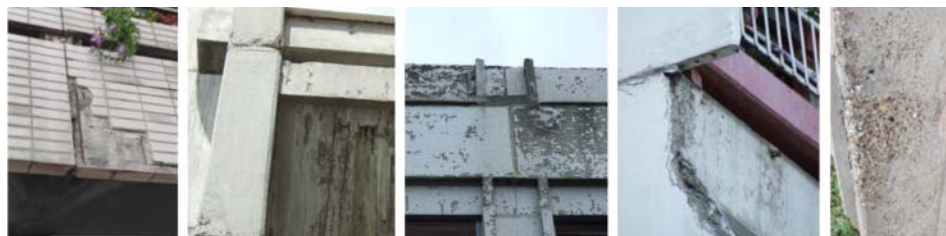
Figure 3: Diverse types of façade damages

In the case of the Scenario II, non-transparent zones have a complete treatment in order to repair all the present damages. How different types of damage are represented on the selected facades, such as: small cracks, mesh cracks, cracks, areas with broken parts of facade elements and structural layers, occurrences of corrosion, damaged protective layers of concrete, damages in joint areas, etc. (Broomfield, 2003), it is necessary to treat such surfaces in order to repair them (Figure 3). The first phase in the formation of Scenario II represents the treatment of non-transparent zones with the aim of their renovation. Such renovation does not have the character of energy improvement, because with
