## CHALLENGES OF NEW CEMENT-BASED TECHNOLOGIES IN HUMID ENVIRONMENT OF EQUATORIAL AFRICA: LIBREVILLE EXAMPLE

The paper will present the challenges faced in the construction and execution of works with newly developed high-performance polymer-cement based material and casting technique, on the completion of the Central archive building project in Libreville. The complete ban on movement during the pandemic led to a disruption of works, and the continuation faced serious restrictions, with almost four years passing between the delivery of materials, the start of works, and their resumption. During the pandemic, the conditions for storing materials were far from the prescribed standards, and the works were unprotected. All materials and works went out of warranty. Given the importance of the facility, the prescribed quality of the works had to be achieved. Replacing the unapproved materials and removing unfinished works was not an option due to high costs, unacceptable delays and environmental issues. Since there was no previous experience with this new type of material that has been stored so long, new technology of application and testing methodology were developed. Through the app

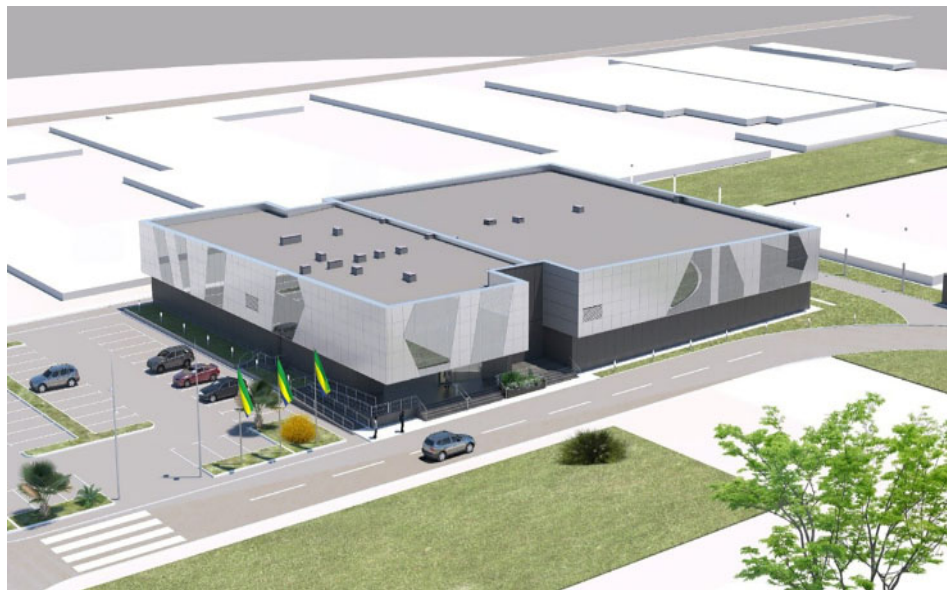
**Figure 1:** Central archive building – 3D view

Launched in 2017–2018, Libreville's urban infrastructure development program aimed to design and construct numerous public buildings across strategic locations in Gabon's capital. One of them, the building of the Central Archive of the DGDI (Direction Générale De La Documentation Et De L'immigration), represents an object of special significance for the administration of the Republic of Gabon. It has been designed as the central building for the DGDI administration with the necessary official premises, offices, and spaces for the central archive, where a large number of important documents in various media are stored, under strict requirements concerning the quality of the materials, equipment, and workmanship used. The building has two floors (ground floor + first floor) and is divided into two functional units: a section for employee work (central hall, meeting rooms, offices for employee work and client interactions, and accompanying service rooms), and a section for document archiving (digital and analogue archives with special storage and access arrangements). The building's structure is made of reinforced concrete, consisting of load-bearing columns and walls, with the arrangement of structural elements in accordance with architectural requirements (see Figure 1). The finishing materials have been selected according to the importance of the building: the façade is designed as a modern curtain wall, while the interior finishes are defined by the significance and representativeness of the building. Special attention has been given to the flooring due to high durability and resilience requirements on one hand, and representativeness and

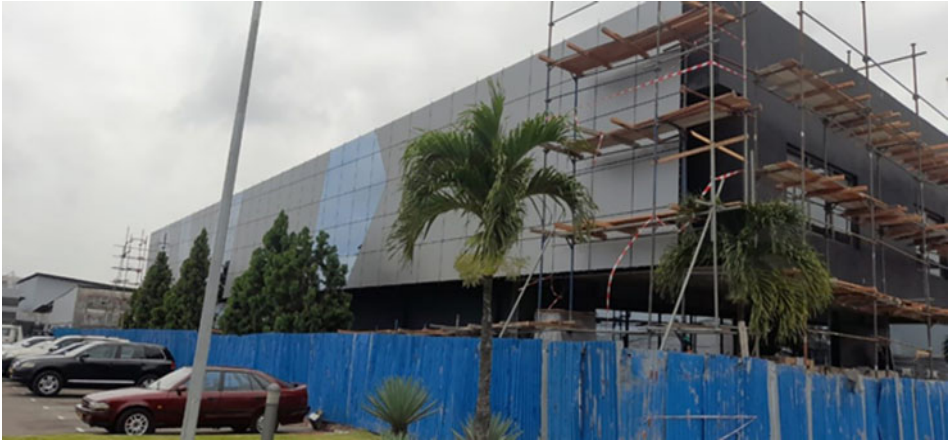
**Figure 2:** Central archive building during construction

After the declaration of the end of the pandemic, activities to resume work on the building were undertaken (see Figure 2). Due to the three-year halt, all warranty periods for materials and equipment had long expired. A significant challenge was assessing the condition of the initiated but unfinished flooring work, particularly regarding the materials used for it. Since the materials are based on cement and polymers that are highly sensitive to moisture, there was a real risk that, after three years of inactivity, the materials had become unusable. Replacing all the materials with new ones would be very expensive. An even greater challenge was transporting the materials from Serbia to Gabon, as shipping was dramatically reduced and slowed down due to the pandemic. Uncertainty in transportation could lead to months of delays in work and jeopardize the completion of the building. It was proposed to check the condition of the materials stored on-site and to assess their usability. Regardless of the assessment results, due to the significance of the building, there could not be a compromise on quality, and it was required that all applied materials come with the same warranties as if they were new.

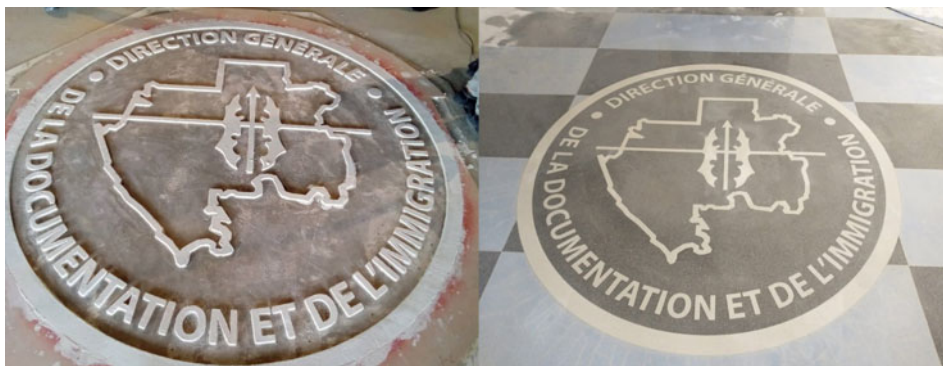
Figure 3: Main hall emblem

The greatest concern was the assessment of the long-term properties of the material and the durability of its aesthetic characteristics. In order to obtain the necessary data on the behaviour of the material, tests were conducted (both on-site and at the production site) on samples obtained by casting and processing various complex shapes in special moulds. The samples were subsequently finished and subjected to tests simulating the environment in which the material would be placed. Conditions in public spaces, as well as conditions in archival rooms, were simulated. The material did not show any hidden defects or tendencies towards colour loss, smoothness, cracking, and similar issues. Based on the obtained results, it was concluded that the stored material could be used without any restrictions. This enabled the execution of all designed complex shapes in the floor (see Figure 3).
