## Landslide events in Slovenia 2023: causes and consequences

Mateja Jemec Auflič<sup>(1)\*</sup>, Jernej Jež<sup>(1)</sup>, Ela Šegina<sup>(1)</sup>, Tina Peternel<sup>(1)</sup>, Andrej Novak<sup>(1)</sup>, Špela Kumelj<sup>(1)</sup>, Domen Turk<sup>(1)</sup>

1) Geological Survey of Slovenia, Dimičeva ulica 14, 1000 Ljubljana, [mateja.jemec-auflic@geo-zs.si](mailto:mateja.jemec-auflic@geo-zs.si)

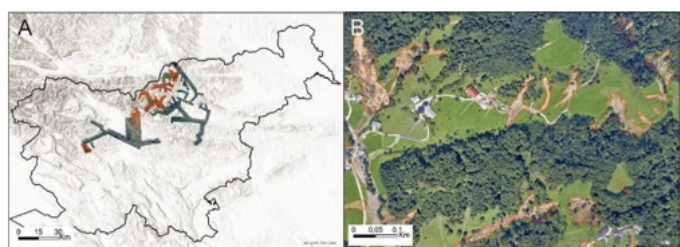
Figure 3 A-The extent of available DOF data. B- Visual digitization of landslides from DOF.

The actual conditions in a limited area are to be captured by the accessible method (remote sensing, field inspection etc.). In our case, in the most affected parts of the country, interventive aerial photography was performed right after the event on 7 and 8 August 2023. Systematic landslide digitization was carried out on a part of a photographed area. Digitization of landslides from DOF was performed using the method of manual visual interpretation (Scaioni et al. 2014). A total of 2142 landslides have been evidenced on 1620 km<sup>2</sup> (Fig 3 A, B).

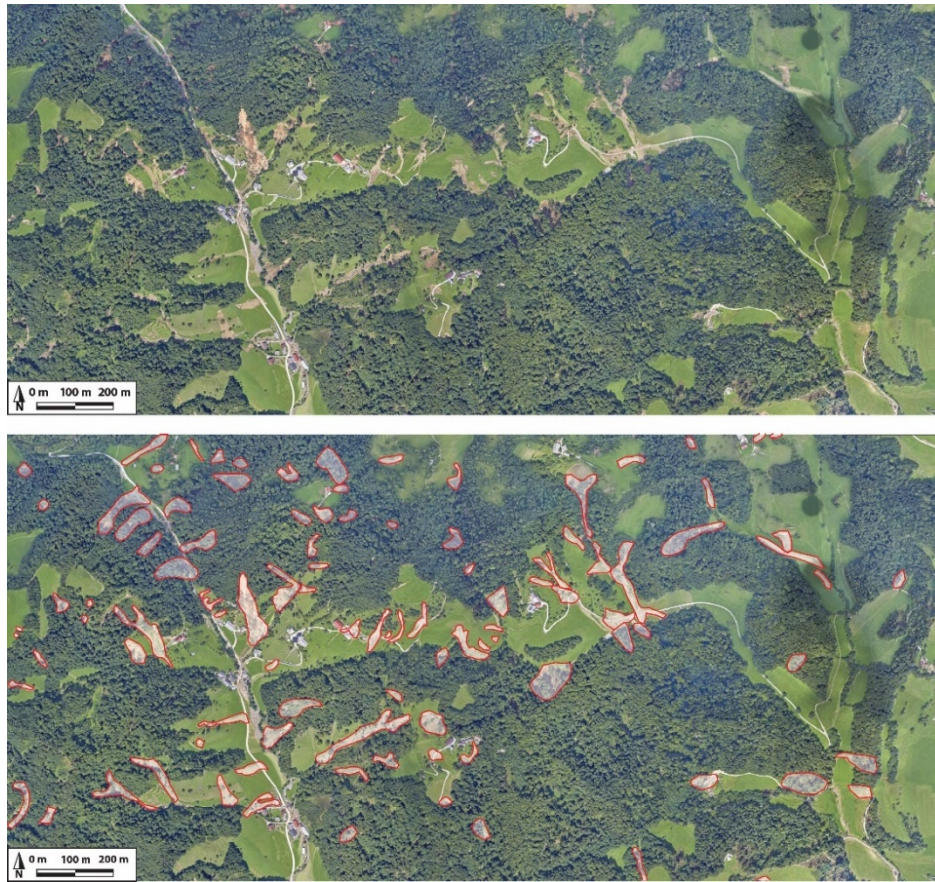
Figure 5 Comparison of a section from a digital orthophoto image of the area of Lanišče in the municipality of Kamnik, where the area consists of Oligocene clastic rocks. Over 50 landslides can be counted on an area of about 1 km<sup>2</sup> (polygons outlined in red), most of which have turned into mud or debris flows. As a result, their area of influence and thus the damage was much greater.

We estimate that up to 10,000 slope mass movements were triggered in Slovenia during the event, with exceptionally high densities in some areas. (Fig. 5). The affected areas of the individual landslides, i.e. the areas of material deposition, show that these was extreme event that differ from the previously known landslide phenomena in these areas. In very few cases was the landslide deposited in the immediate vicinity of the source areas (Fig. 5). Due to the large amounts of water, the landslides often mobilised into mud or debris flows (Fig. 6), whose material was deposited on the foothills 10, 50, 100, sometimes even more than 100 meters away from their original location. As a result, facilities and infrastructure were also affected and threatened, sometimes far from the primary areas of origin of the phenomena (Fig. 6 A and B).

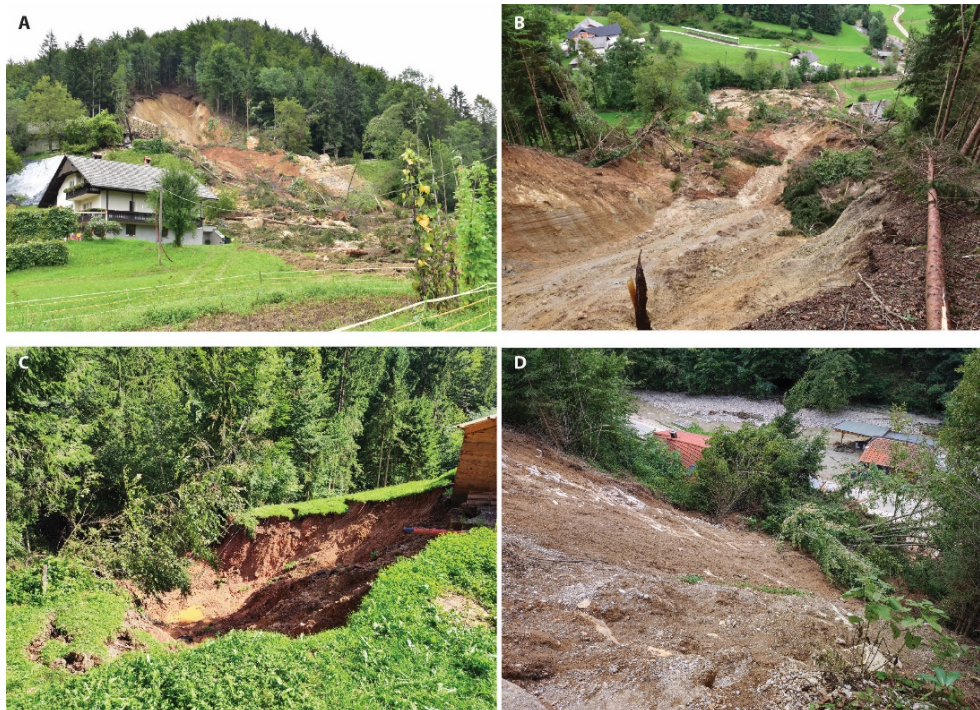
Figure 6 Examples of slope mass movements. A) Landslide that has mobilised into a debris flow, consisting of sand, gravel and several boulders with a size of several m<sup>2</sup>. B) At the bottom of the valley, the debris flow has partially covered the stream bed. C) An example of a landslide that has mobilised into a mudslide of sand, silt and clay. D) An example of a water-saturated slide with roots and trees that led to the complete destruction of a house. The landslide occurred on a limestone base, which is unusual for landslides to occur.

In most cases, the weathered soils are covered by clastic sediments of varying thickness. In Koroška region there is also weathering of metamorphic and magmatic rocks. Less frequent were cases of wedge-shaped rockfalls, where material slid along deep structural discontinuities in the slope. In some exceptional cases, landslides occurred on very unusual geologic units where they would not otherwise be expected, such as steep limestone and dolomite slopes. In these cases it was a shallow landslide with roots and trees, indicating that there was an exceptional amount of water liquefying the soil (Fig. 6 C).

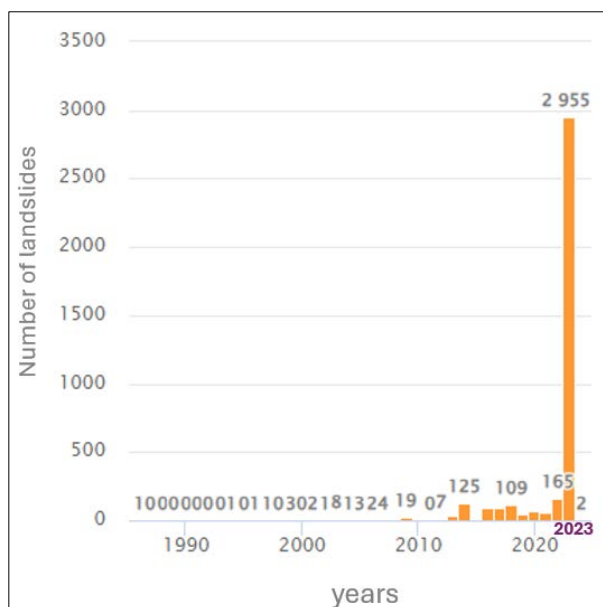
Figure 7 Recorded landslides in the e-Plaz application for landslide collection after rainfall event in August 2023.

The lateral mass movements also had a significant impact on watercourses by introducing a greater amount of sediment into the riverbeds, streams and torrents. Larger quantities of material remained in the riverbeds after collection, which present a risk for triggering bedload and hyper-concentrated flows during heavy rainfall. At the end of February 2024 the landslide database contained 2955 landslide events reported in municipalities after flood event in August 2023. Even this inventory does not reflect the full number of landslides, as municipalities are still entering landslides into the database.
