Rock collapse structure on the Liburnian coast (Rijeka Bay, NE Adriatic)

Abstract The studied rock collapse structure is located on the Liburnian coast (Rijeka Bay, channel zone of the NE Adriatic). The relief of the southern part of this coast, with a length of 6.5 km, is a large escarpment with very steep to vertical slopes reaching heights of 100 m above sea level, as a result of tectonic movements along the Kvarner fault zone. These events probably led to a sudden relaxation of the highly fractured rock mass. The progressive extension occurred in places where previously favourably oriented paraclases of faults and fissures had formed a very large and complex rock collapse. The width of the displaced mass along the coast is 375 m and the estimated total volume of the displaced rock mass is 2,400,000 m³. The lower part of the instability phenomenon lies 40 m below MSL and it was submerged during the Holocene sea level rise. A large part of the displaced rock mass was in a stable position, with sporadic rock falls. Recent techniques to survey the instability site and to analyse the evolution of the rupture surface and its dimensions above and below the sea level were used and com

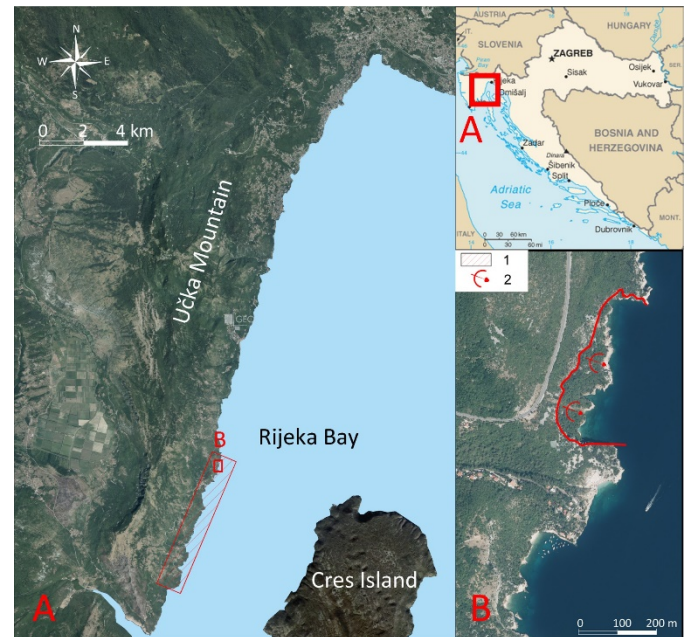
Figure 1 Location and simplified geological maps A) the Liburnian coast: 1- position of escarpment B) study area: 2 - studied collapse structure.

The Liburnian coast is located on the western coast of the Rijeka Bay. It is part of the Kvarner channel zone of the northeastern Adriatic. The relief of the southern part of this coast looks like an escarpment. This 6.5 km long escarpment, is characterized by very steep to vertical slopes, that reach a height of 100 m above mean sea level. The submarine slopes are also very steep, so that the isobaths of -50 m run close to the coastline (Figure 1).

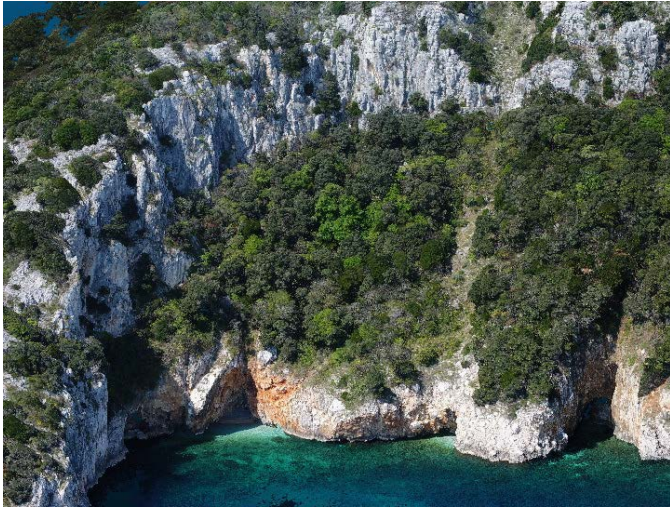
Figure 3 Tectonic breccia on the southern edge of collapse structure (Photo: D. Kalajžić).

The shallow part of the bottom near the coastline has a gentle slope inclination. Marine erosion is more pronounced on the coast, which consists of cataclastic breccias. A narrow marine terrace and a pocket beach have formed there (Figure 3). Tidal notches are formed due to the bioerosion of limestone rocks, predominating on the central-northern part of studied collapse structure. (Figure 4). Based on the underwater survey insight, the bare rock mass is visible on the lateral side of the investigated instability (Figure 5). Boulders with a diameter of up to 50 cm are located at a depth of 40 m (Figures 2 and 6). The deeper part of the bottom is slightly inclined and covered with sandy sediments. The landslide toe is located at a depth of about 40 m below mean sea level. The total volume of the displaced rock mass as about 2,400,000 m³.

Since the beginning of instrumental measurements, sea level rise in the northern Adriatic has been recorded in the range of $2.0 \pm 0.9 - 3.4 \pm 1.1$ mm/year (Surić et al., 2014; Tsimplis et al., 2012). New climate models predict extreme wave storms (Bonaldo et al., 2017) and increased marine erosion in the Adriatic Sea (Gallina et al., 2019). Because of this, wave attacks could be stronger and higher in the future on this studied coast. Marine erosion could be especially expressed in These lees-resistant cataclastic breccias (Figures 2 and 3). It can be a triggering effect for increasing landslide hazard increase.

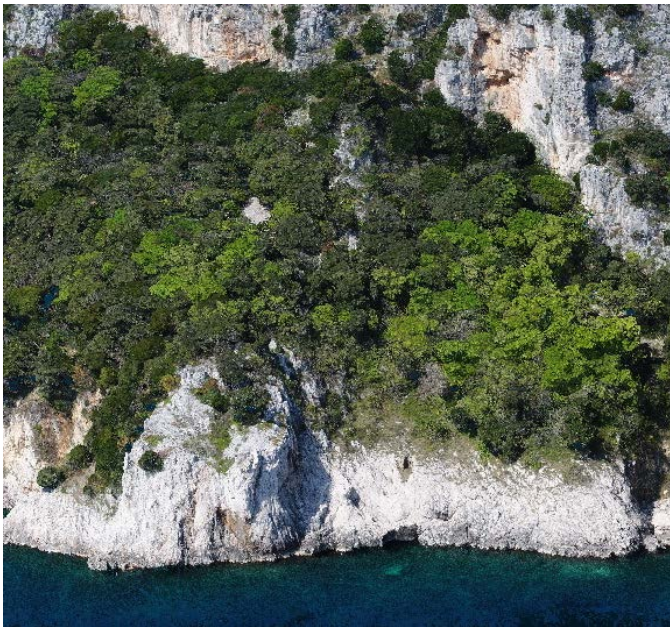
Figure 4 Strongly fractured and karstified limestone rock on the northern side of the collapse structure (Photo: D. Kalajžić).

The collapse structure consists of two lithologic types. Cataclastic breccia is found in the southern part of the studied instability. This rock mass consists of angular fragments originating from limestone. The range of fragments is a few centimeters to blocks with a diameter of one meter. The matrix is calcitic reddish clay (Figure 3). A strongly fractured and karstified limestone rock mass there is in the central and northern parts of the collapse structure (Figure 4).

Intertidal notches are visible in relatively resistant limestone rocks mass (Figures 2 and 4). The measurements in other locations show that the elevation points are located at similar depths of elevation points that have been found elsewhere on the Liburnian coast (Benac et al., 2004). Therefore, it can be assumed that the upper part of the sliding body was in a relatively stable position before the Late Pleistocene-Holocene sea level rise (Benac et al., 2023). The measurement of elevation points of the tidal notches at the location analysed in this paper could provide interesting data on the recent stability of the collapsed structure.

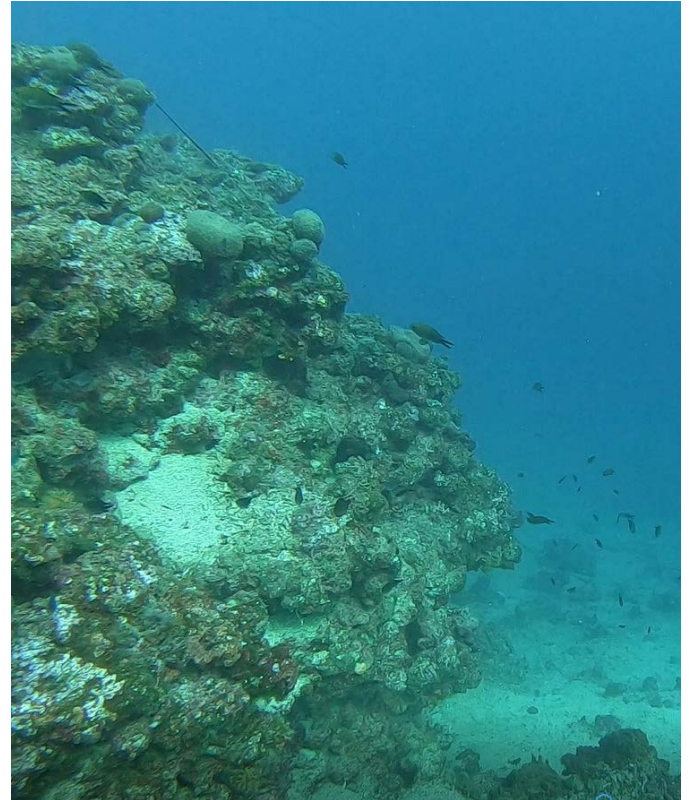
Figure 5 Rock mass on the southern edge of collapse structure (Photo: L. Maglić).

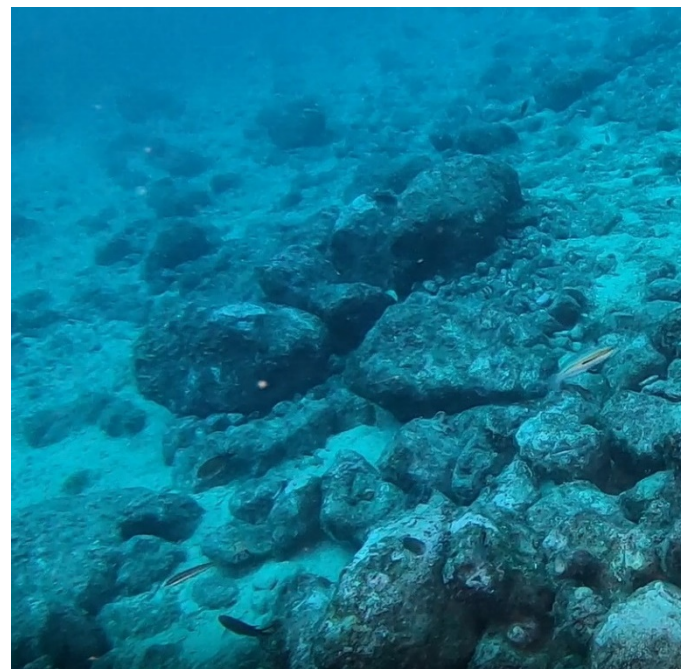
Figure 6 Boulders on the foot of sliding body 40 m deep (Photo: L. Maglić).
