## Geological-Geotechnical Exploration for the Landslide mitigation Section at the Old Cemetery in Smederevo

**Abstract:** The slope where the Old Cemetery in Smederevo is situated has been shaped by landslide processes. These are most likely deep but dormant landslides with the failure surface of over 20 m. Active landslides occur in shallow, near surface areas, with the failure surface of about 2 m. In addition to present exogenic processes, human activities such as cutting, filling, land development etc. also impact the landscape. The study microlocation occupies the slope section in the Old Cemetery northern boundary area from Karadorđeva Street to Koče Kapetana Street. The slope gradient in this section is about 45°. The slope stretches to the Danube river alluvial plain, with elevations ranging from 74 to 74,5 m, whereas the elevations in the slope section under consideration range from 77 to 90 m. Overall stability of the slope is ensured by an RC retaining system – a concrete diaphragm wall built at the slope toe, whereas traces of active landslide and failures with their effects are clearly visible in higher sections of the slope. The study area is made up of the sediment

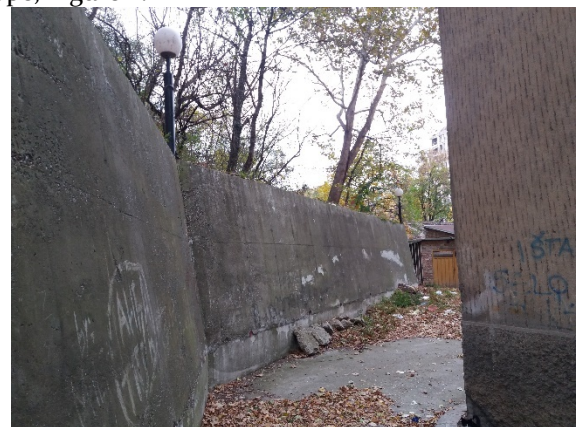
Figure 1. A section of the existing retaining system at the slope toe

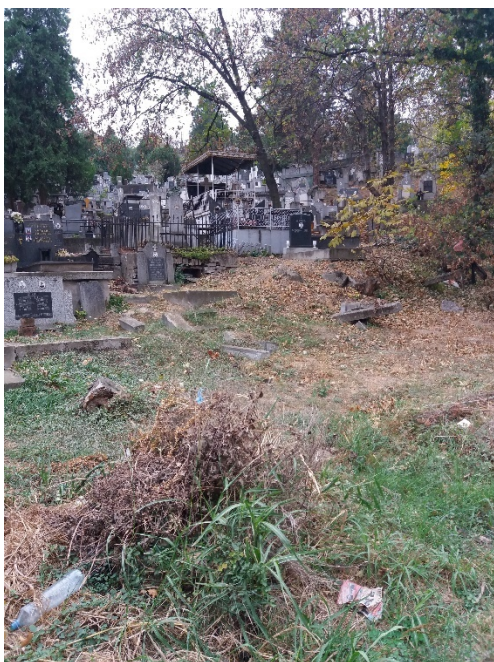
Figure 2. Landslides and failures in higher sections of the slope

The study microlocation occupies the slope section in the Old Cemetery northern boundary area from Karadorđeva Street to Koče Kapetana Street. The slope gradient in this section is about 45°. The slope stretches to the Danube river alluvial plain, with elevations ranging from 74 to 74,5 m, whereas the elevations in the slope section under consideration range from 77 to 90 m. Overall stability of the slope is ensured by an RC retaining system – a concrete diaphragm wall built at the slope toe, Figure 1, whereas traces of active landslide and failures with their effects are clearly visible in higher sections of the slope, Figure 2.

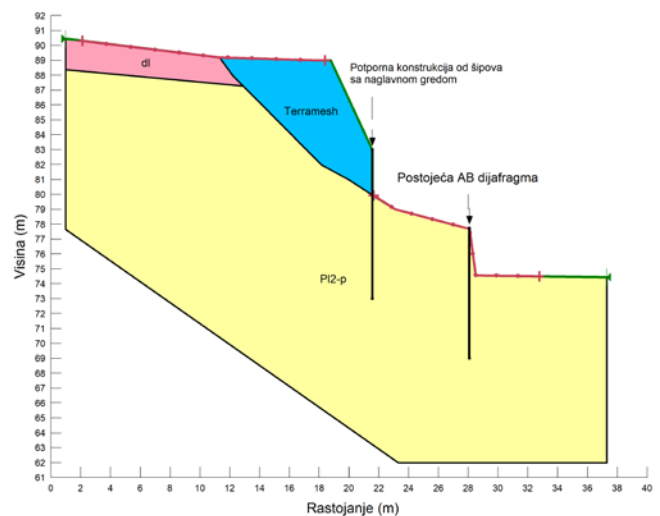
Figure 3. Geoen지니어ing model at GT cross section 1-1'

*Geostudio 2012* – *Slope/W* software and *the Morgenstern-Price* limit equilibrium method were used in the analyses. The geoen지니어ing model at the cross section 1-1' was adopted in the analyses (Figure 3).
