Addressing Rockfall Challenges in flysch environment - A case study from Greece

Themistoklis Chatzitheodosiou^{(1)*}, Ioannis Farmakis⁽²⁾, George Prountzopoulos⁽³⁾, George Stoumpos⁽¹⁾, Dimitra Papouli⁽¹⁾, Thomas Thomaidis⁽¹⁾, Vassilis Marinos⁽¹⁾

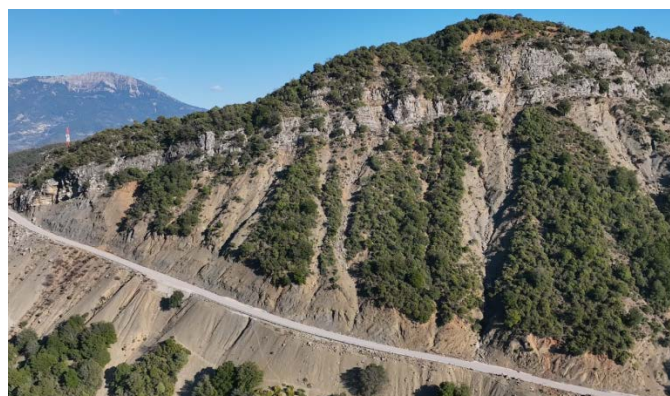
Figure 2 Aerial view of the Valaora region illustrating steep terrain where rockfalls threaten the road and public safety. Visible scars across the landscape mark recent rockfall events, underlining the need for continuous monitoring and mitigation. The potential trajectories of rockfalls from the upper sections of the slope, through thalwegs, to the road level are of particular concern.

The Valaora region, situated in the western part of the Evritania prefecture near Greece's artificially created Kremaston Lake, is characterized by its steep and precipitous slopes (Fig. 1,2). Recognized as one of the most susceptible areas to landslides in Greece, the mountainous terrain of Evritania necessitates a thorough engineering geotechnical analysis to secure infrastructure and public safety in this high-hazard zone (Marinos et al., 2015).

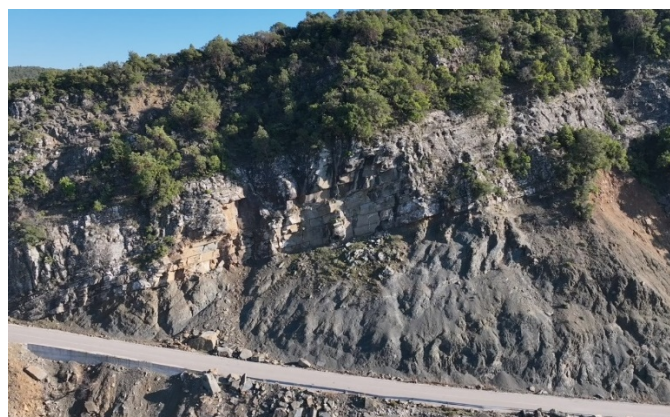
Figure 3 Significant rockfalls involving sandstone at the slope NE edge, directly above the provincial road. This activity is intensified by the undercutting of sandstone caused by the differential erosion of siltstone beneath it.

Stability challenges in the area are significant, with rockfalls posing a severe threat to the adjacent provincial road. Medium to large boulders ranging from approximately 5 to 10 m³, often detach from the upper slopes, posing hazards due to the lack of protective infrastructure. Erosion and shallow slides, especially towards the area's northeastern parts, further contribute to the instability, undermining the surface layer and leading to potential road safety threats. Moreover, rockfalls occurring directly above the road (Fig. 3), amplify these dangers, compounded by the slope's steepness and the lack of catchment barriers.

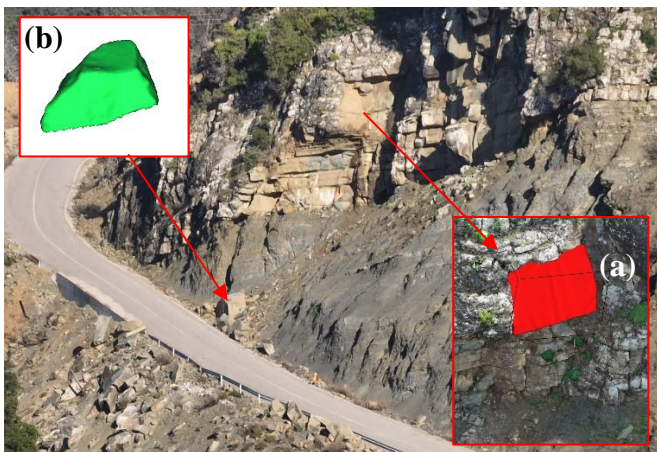
Figure 8 The northern section of the slope clearly reveals the origin of rockfalls in Type III flysch above Type VIII. The failure mechanism is evident, characterized by the undercutting of the sandstone as a result of the differential erosion of the underlying siltstone. a) the main rockfall source with 13 m³ volume, measured by digital reconstruction of the detachment geometry, and b) a 6.5 m³ block from this detachment, located on the slope side.

In the northern section of the study area, Flysch Type III is positioned at a modest elevation above the road, reaching a maximum of 25 m above a highly disturbed-folded rock mass (Fig.8). This underlying mass, not significantly deformed or sheared, consists of siltstone with layers of sandstone (**Type VIII**). Moving southward, the Type III Flysch formation is found at a higher altitude, above moderately disturbed siltstone with thin layers of sandstones (**Type VI**), and in the southern part, it reaches a maximum height of 90 m above a highly disturbed-folded rock mass (Fig.2). This mass retains its structure and is made up of alternating siltstones and sandstones (**Type VII**).

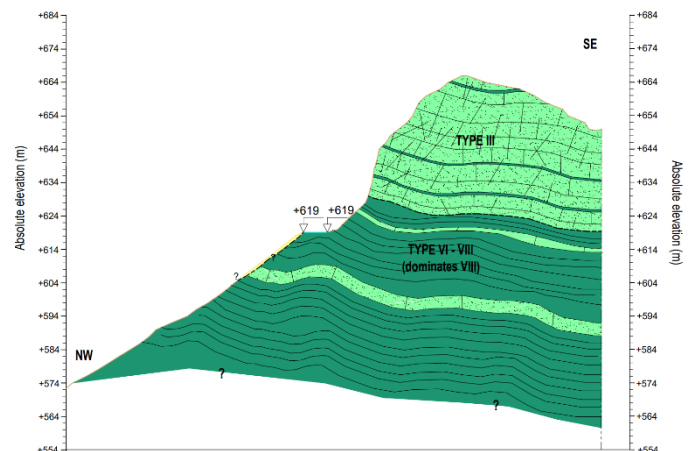
Figure 10 Engineering Geological Section: This section is illustrated in red on the engineering geological map (Fig.9).

Results highlighted significant concerns regarding vertical trajectories towards road infrastructure in the northern sector dominated by Type III flysch (Fig. 10,11). Peak kinetic energies at the road level were estimated to be between 6200-6500 kJ, for rockfall volumes of approximately 13 m³, originating from a detachment height of around 20-30 m. However, the potential rock fragmentation during descent indicates that actual impact energies could be lower.
