EXPERIMENTAL STUDY REGARDING THE CORROSION BEHAVIOUR OF HEAT EXCHANGER BRASS TUBES IN THE PRESENCE OF DIFFERENT AGGRESSIVE ENVIRONMENTS

Original scientific paper

Ibrahim Ramadan¹, Maria Tănase^{1*}

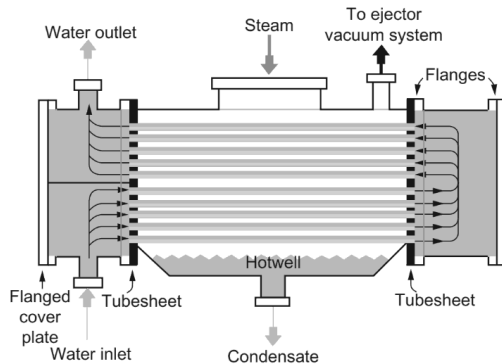
Fig.1. Typical water-cooled surface condenser [3]

Heat exchanger type condensers used in the chemical and food industries are usually formed by coils through which condensed vapors circulate, immersed in a water cooling vessel (Fig.1).

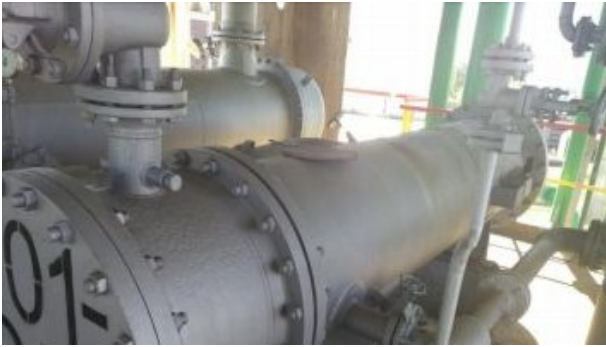
Fig.2. The condenser considered in the case study

The first step in the experimental investigation of brass tubes was to evaluate the technical condition of in-service brass tubes after a certain period of operation, for a condenser used in petrochemical industry (Fig.2), with the working parameters presented in Table 1. During a basic periodical technical inspection, samples were taken from the brass tubes in order to evaluate their technical condition.

spectroscopy using the Oxford Instruments Foundry Master-Pro Spectrometer, for samples taken from different areas of the tubular material which worked for different periods of time in the condenser presented in Fig.2. Three determinations were made for the main chemical elements of the tube material and the results obtained are presented in Table 2.

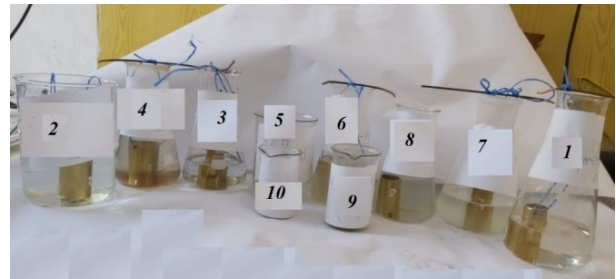
Fig.3. The samples used for the experimental study

For the second direction of the experimental study, a CuZn36 tube was used, with 25 mm outer diameter and 2 mm thickness. Several rings of 50 mm were cut, as can be seen in Fig.3, and immersed in different environments for 21 days.

The samples markings and the corresponding immersion environments are presented in Table 3.

For the simulation of the working environment of the tubes in the analyzed condenser, sample 11, of the same CuZn36 tube was partially immersed in water and boiled 2 hours a day and cooled in the air repeatedly for a 7 days period.

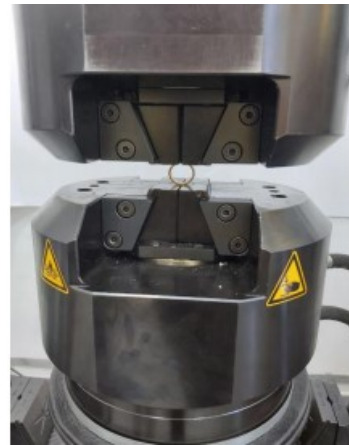
Fig.4. The device used for the flattening test

The test pieces were placed between the two platens of the Walter Bai LF300 Universal Testing Machine, the rate of movement of the platens was 5 mm/min and a load was applied until the internal surfaces were in contact. The tests were carried out at ambient temperature (22 °C).

In order to mechanically estimate what happened to the exposed tubes, the flattening test

was used [23], so test pieces of 10 mm were cut from the exposed samples (Fig.4 and Fig.5).

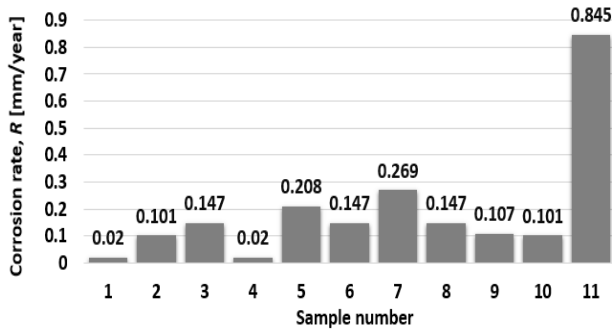
Fig.6. Comparison between the corrosion rates for different immersion environment

Also, Table 4 presents the final aspect and the corrosion rates for all the samples immersed in the considered environments. The comparison between the calculated corrosion rates for the samples exposed is presented in Fig.6.

The influence of different aggressive environments can be easily evaluated by determining the corrosion rate. From the Fig.5 it results that the most affected is sample 11 which was boiled, meaning that the CuZn36 material is mostly affected by the presence of water at high temperatures, so the specific working conditions of condensers will eventually led to acute corrosion of tubes. The samples immersed in NaClO solutions were more affected than the samples immersed in water or NaCl solutions.
