DESTRUCTION OF ARCHAEOLOGICAL AND CULTURAL HERITAGE IN THE AREA OF SVRLJIG

ABSTRACT

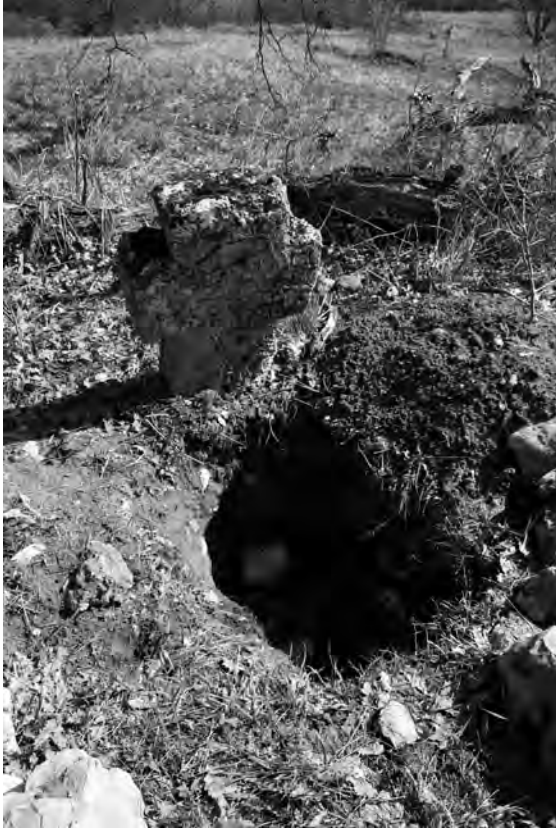
all sites have drilled holes and dimples with the depth to 20 cm (fig. 1). In this context, it should be emphasized the destruction of cultural layers in many of so far even unregistered caves. Moreover, the natural fractures in the rocks are considered to

Fig. 1 Big hole under the village stone cross made by treasure hunters

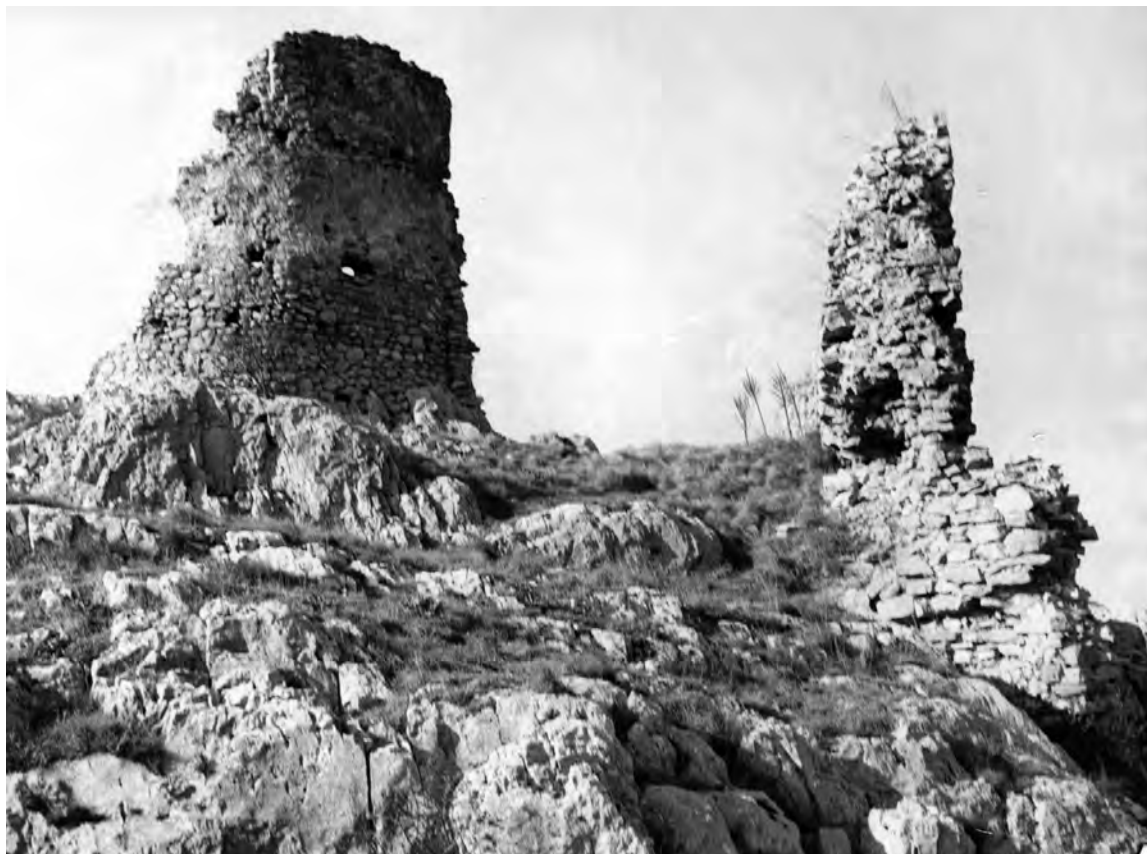
was better preserved, with a height of about 12 m. Experts from the Institute for Protection of Cultural Monuments in Niš visited the area about 25 years ago and then concluded a satisfactory degree of conservation of the architecture (fig. 2a). During the 1999 bombing, the local treasure hunters took advantage of the war and they blew up two towers by dynamite. The round tower then collapsed to a height of about 3 m (fig. 2b), while the rectangular is brought beyond recognition and its height does not exceed 2 m. Architectural structures in the suburbs are also targeted by local treasure hunters. At the fort Kulište in the village of Manojlica, defensive rampart is cut with a hole about 2 m wide and 2.5 m deep. Below the fort, at the plateau next to the Manojlička River, the half meter wide hole is recently dug, with the depth of more than 3 m and length of about 6 m. At the site Gradac next to the village of Grbavče only 25 years ago (fig. 3a) were registered the remains of fortifications with walls about 1.5 m wide, several towers and small suburb. Today, this site on the small mount is completely bare (fig. 3b), and on its milder slopes local treasure hunters continue to chase for treasures and to destroy the foundations of this fortress.

Fig. 2a Round tower on the Svrlijig fort, 1984

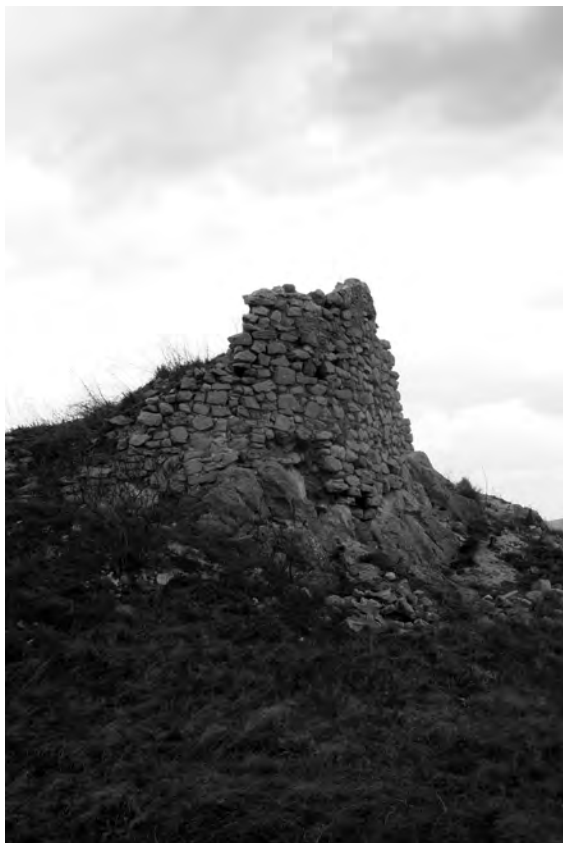
Fig. 2b Round tower on the Svrljig fort, 2007

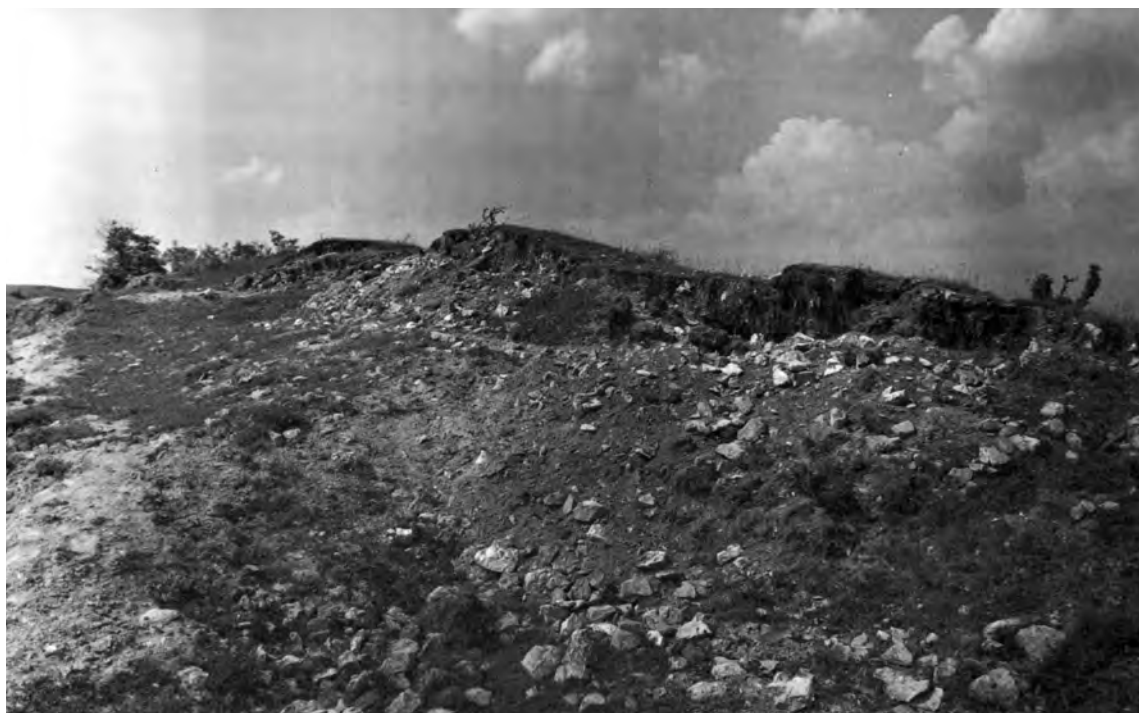
Na antičkim, vizantijskim i srednjovekovnim utvrđenjima, bedemi i kule očuvani do visine od nekoliko metara i prekriveni šutom i gustom vegetacijom, često su potpuno izbušeni rupama dubine i do nekoliko metara, dok se zidovi neretko presecaju i kopaju ispod temelja. Najugroženije utvrđenje je, svakako, stari grad Svrljig. Kanić i Mišković precizno opisuju njegove ostatke pre 125 godina i kažu da okrugla kula sa 4 sprata i očuvanim vratima ima 10 m u visinu, dok je pravougaona kula bila još bolje očuvana, sa visinom od oko 12 m. I pre 25 godina konstatovan je zadovoljavajući stepen očuvanosti arhitekture na Svrljig gradu (sl. 2a), ali su tokom bombardovanja 1999. godine lokalni tragači za blagom iskoristili ratno stanje i dinamičkom razneli obe kule. Okrugla kula tada je srušena do visine od oko 3 m (sl. 2b), dok je pravougaona dovedena do neprepoznatljivosti i njena visina ne prelazi 2 m. Na lokalitetu Gradac u selu Grbavče, do samo pre 25 godina registrovani su vidljivi ostaci utvrđenja sa bedemima širine oko 1.5 m, nekoliko kula i manjim podgrađem (sl. 3a). Danas je ovo brdo potpuno ogoljeno (sl. 3b).

Fig. 3a Grbavče fort, 1984
