EMILIJA NIKOLIĆ
 Institute of Archaeology,
 Belgrade, Serbia
 emilij@gmail.com

Original research article
 Received: 25th May 2015
 Accepted: November 15th 2015

THE ROLE OF BRICK IN HYDRAULICITY OF VIMINACIUM MORTARS: DECORATIVE MORTARS FROM THE THERMAE*

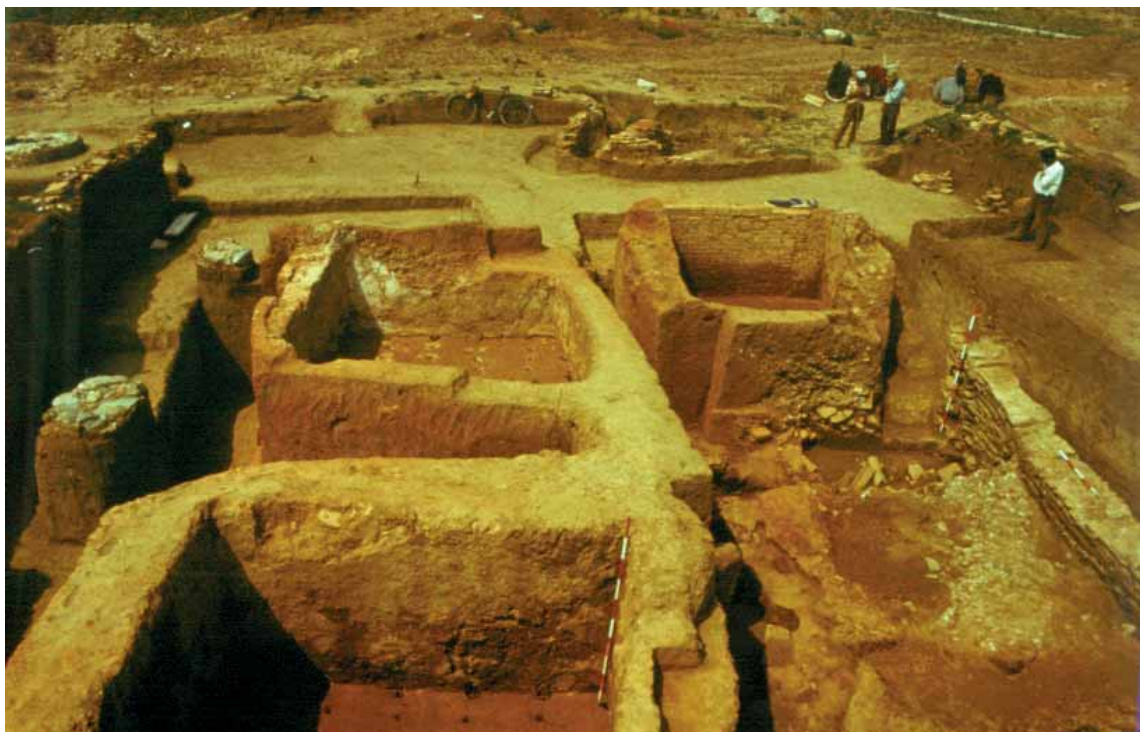
Fig. 1 Brick kilns from the craftsmen's centre during excavations.
Photo-documentation of the Republic Institute for the Protection of Monuments

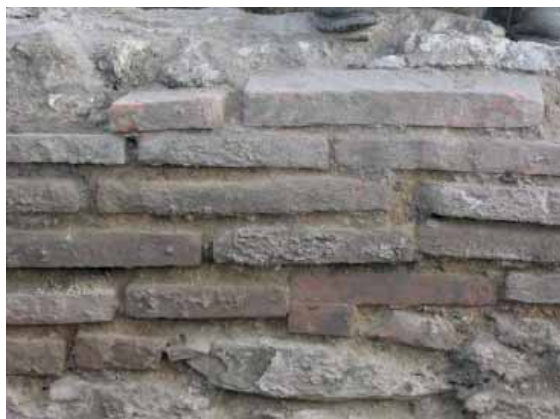
Fig. 2 Brick wall of Viminacium thermae.
Photo-documentation of Institute of Archaeology
Belgrade

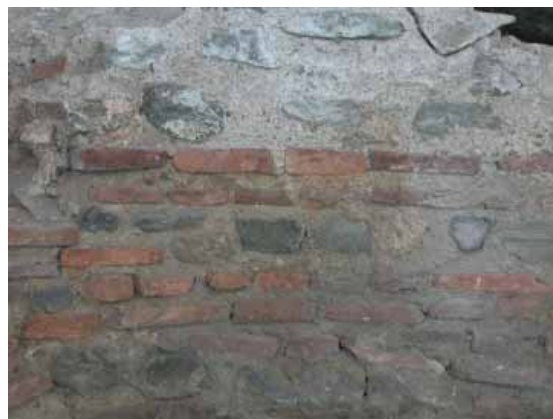
Fig. 3 Bricks in wall facing of Viminacium thermae.
Photo-documentation of Institute of Archaeology
Belgrade

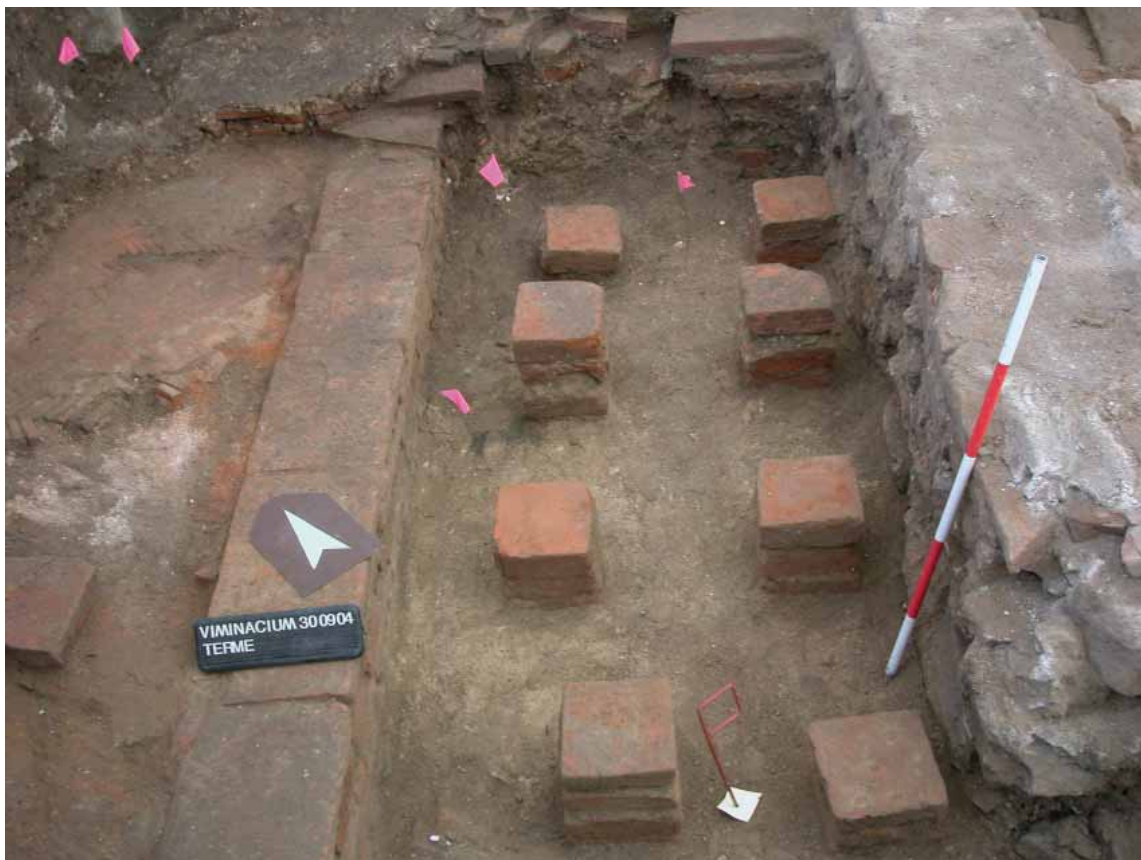
Fig. 4 Bricks of hypocaust and in wall structures of Viminacium thermae.
Photo-documentation of Institute of Archaeology Belgrade

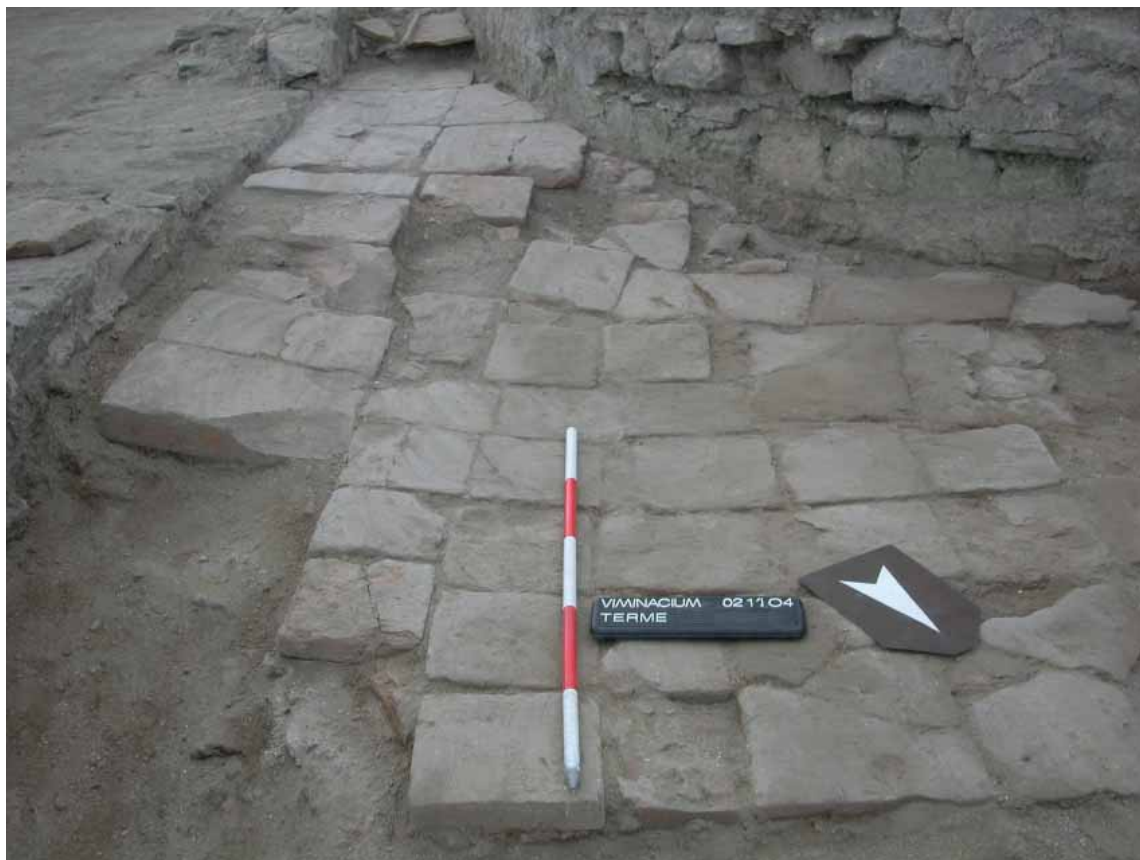
Fig. 5 Bricks as finishing floor layer in Viminacium thermae.
Photo-documentation of Institute of Archaeology Belgrade

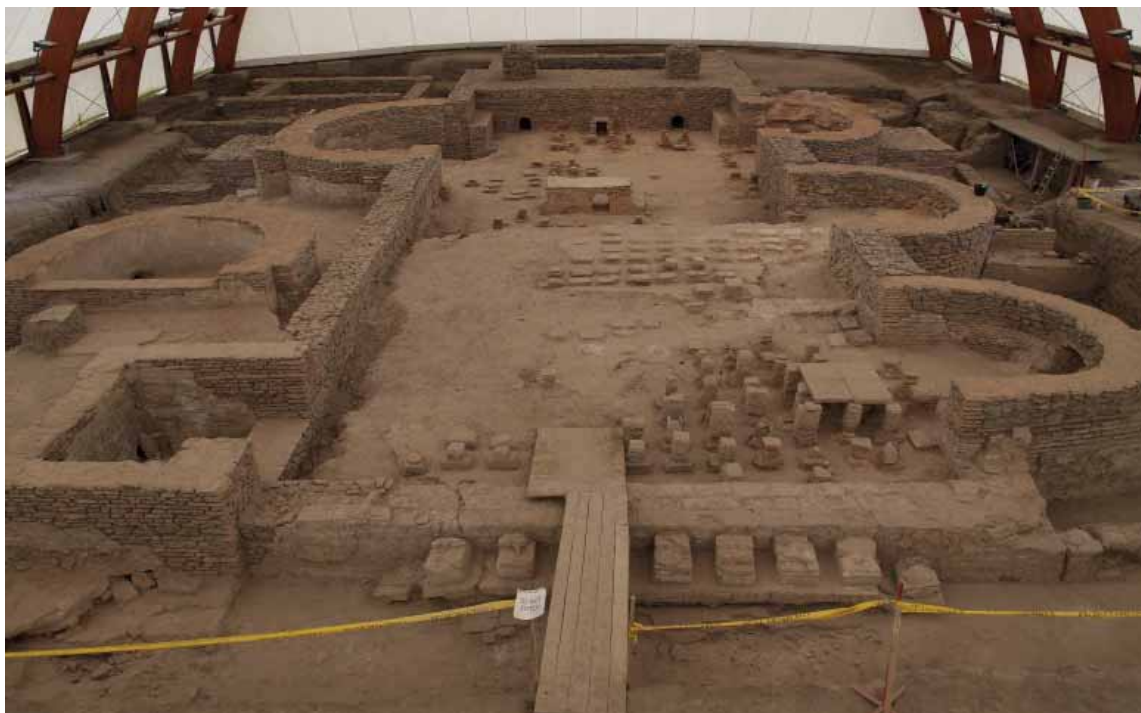
Fig. 6 View of Viminacium thermae today. Photo-documentation of Institute of Archaeology Belgrade

to 2007. (Fig. 6) Both excavations revealed that there were several phases in the building of the thermae, specifically that each subsequent building was erected on the remains of the previous one. (Kondić, Zotović 1974: 96-97, Миловановић 2004: 53) The beginning of the use of the Viminacium thermae can be connected to the end of the 1st and the beginning of the 2nd century, whilst the building lost its primary function at the end of the 4th century AD. (Миловановић 2004: 53; Kondić, Zotović 1974: 96-97) During the archaeological research of the Viminacium thermae, five apses were revealed, along with a central room with hypocaust and several lateral rooms. All of the building parts visible today were in use during the 3rd and the 4th century AD. (Миловановић 2004: 53)

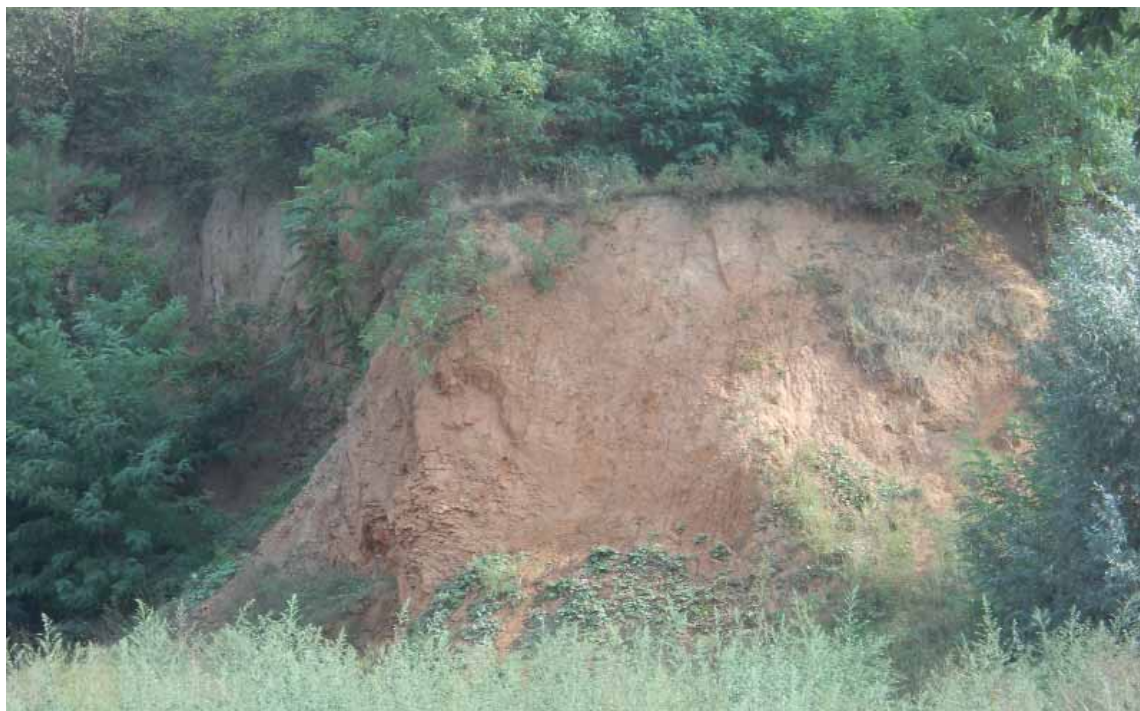
Fig. 7 Hill above Stari Kostolac village with visible red layer of „crvenka“. Photo by the authors

villages around Viminacium, in which there was a underground coal mine during the 19th and the 20th century.⁹ (Fig. 7, Fig. 8) This represents layers of sedimentary rocks which experienced a metamorphosis caused by the combustion of the lower coal layers. Coal could be ignited in a natural way, by spontaneous combustion when coming into contact with oxygen or a lightning strike or a fire caused by some human factor, (Murphy: 2013: 2-3) which is often encountered worldwide under different names, the most common of which are clinker and porcellanite.¹⁰ “Crvenka” was used by the Romans of Viminacium in road and wall core structures¹¹ (Fig. 9, Fig. 10) and, in accordance

Depending on the firing temperature, “crvenka” could be a partially coherent and very porous rock, reminiscent of slag from a blast furnace when it is closer to a source of high temperature, but also a material similar to brick, when it is formed at lower temperatures. (de Boer, Dekkers, van Hoof 2001: 94) In southern England, mosaic tesserae have been found and plates in the *opus sectile* technique, originating from several Roman buildings and made of these naturally fired rocks, from the second half of the 1st and the beginning of the 2nd century AD. Such decorations belong to early Roman mosaics in this territory and there are also indications that there were workshops introducing clinker into elements of interior finishing. (Allen, Fulford 2004: 9-38) These materials were therefore accessible to all the social strata, military, public and private. The largest use of “crvenka” in Viminacium can be placed into the same chronological frame, in the time of the still undeveloped

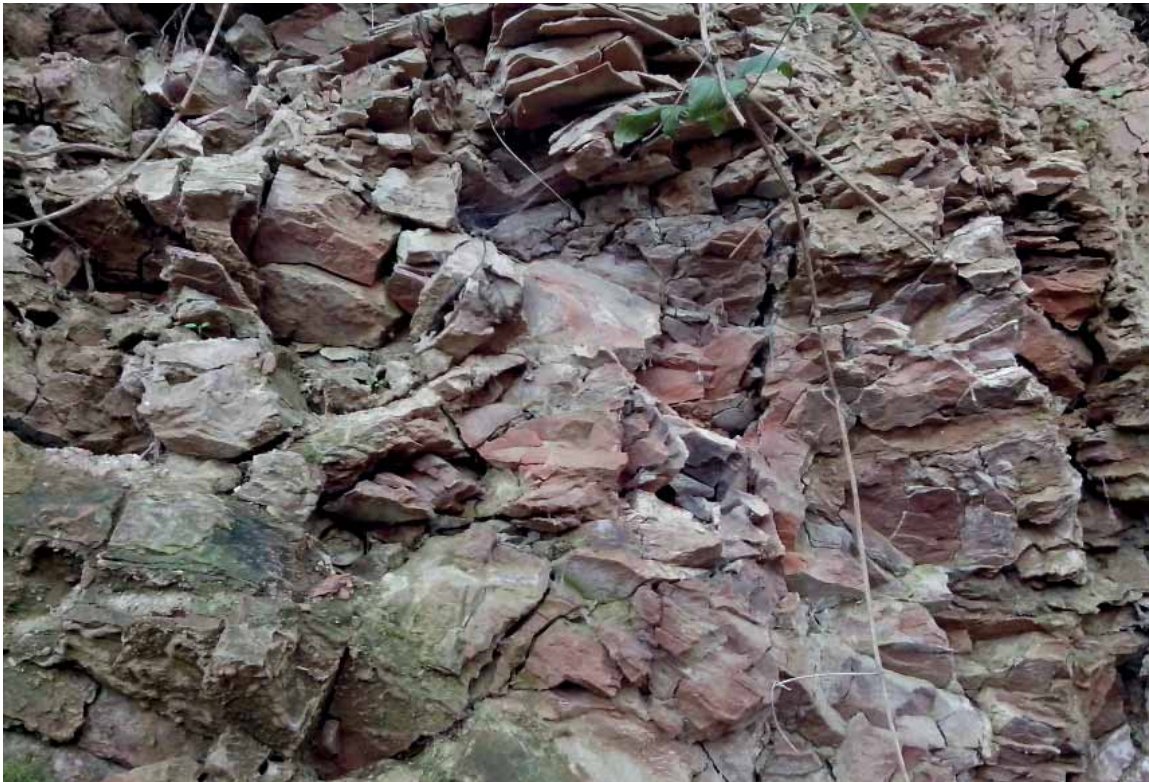
Fig. 8 Hill above Stari Kostolac village with visible red layer of „crvenka“, detail. Photo by the authors

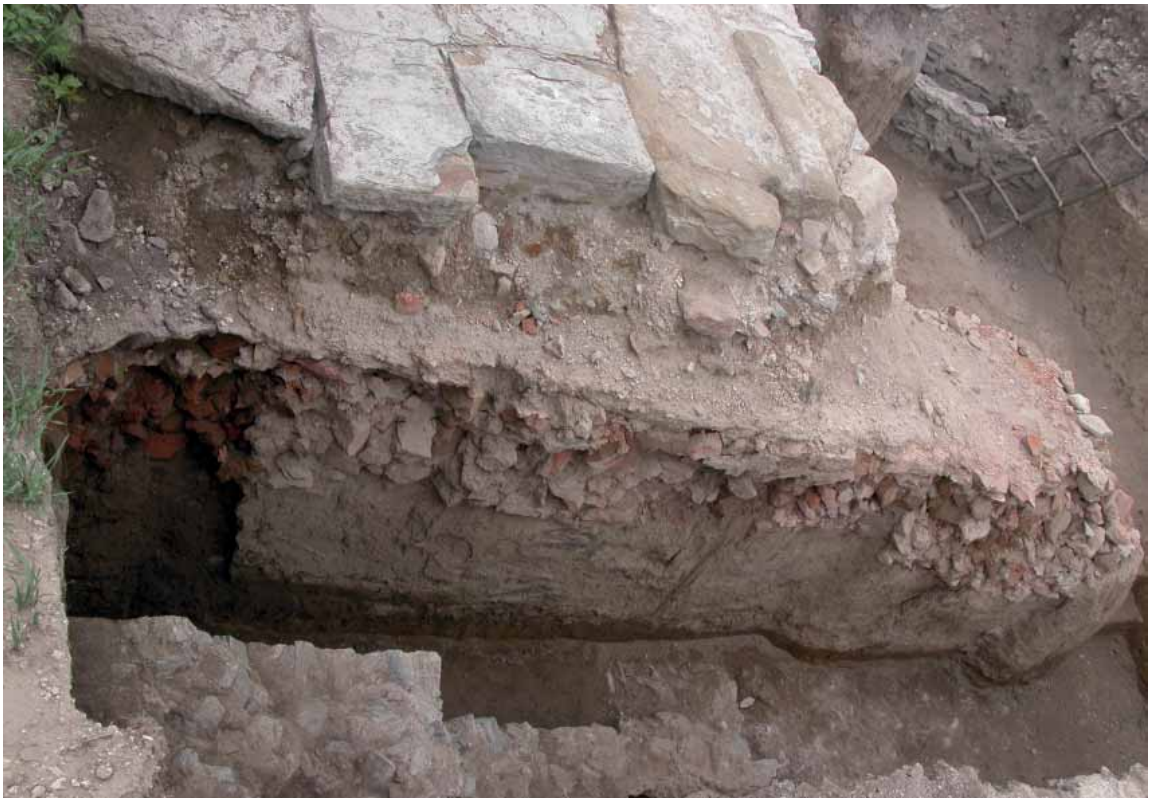
Fig. 9 Part of the early gate tower partially destroyed by the later road entering the northern gate of the legionary fort. Photo-documentation of Institute of Archaeology Belgrade

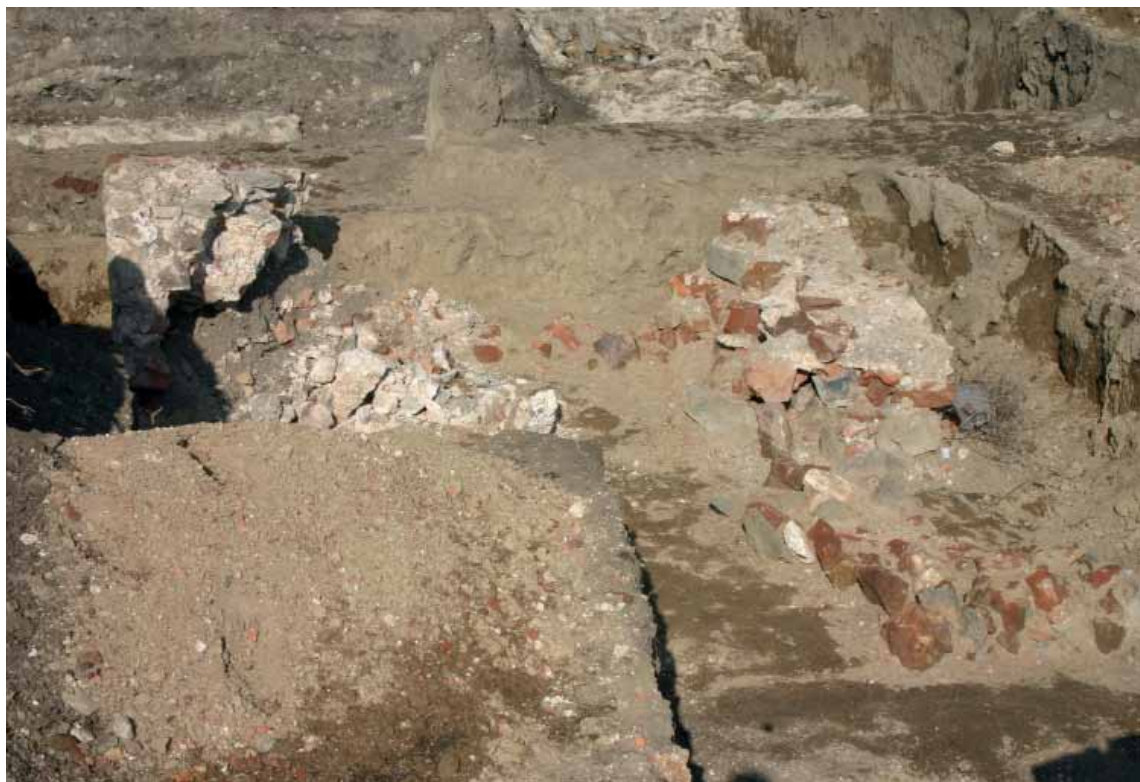
Fig. 10 Foundation structure from the bulding in the temple complex with visible „crvenka“.
Photo-documentation of Institute of Archaeology Belgrade

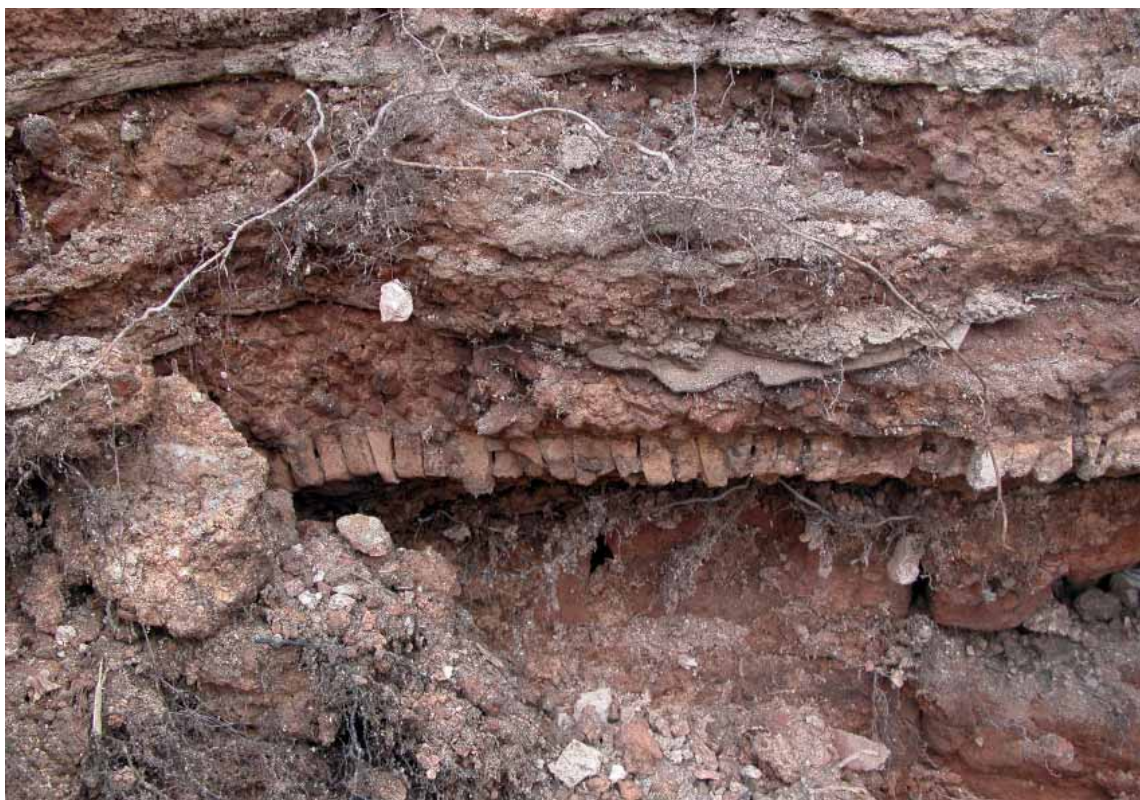
Fig. 11 Floor layers of Viminacium thermae with brick in the form of large fragments.
Photo-documentation of Institute of Archaeology Belgrade

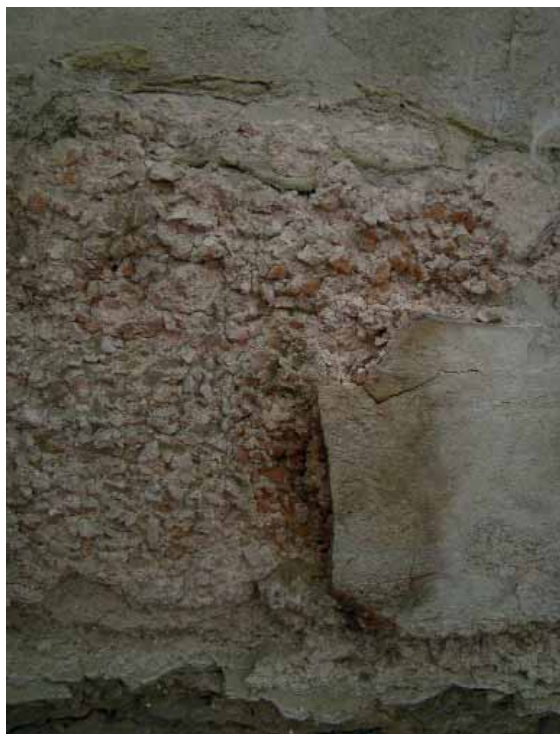
Fig. 12 Rendering layers of Viminacium thermae with brick in the form of large fragments.

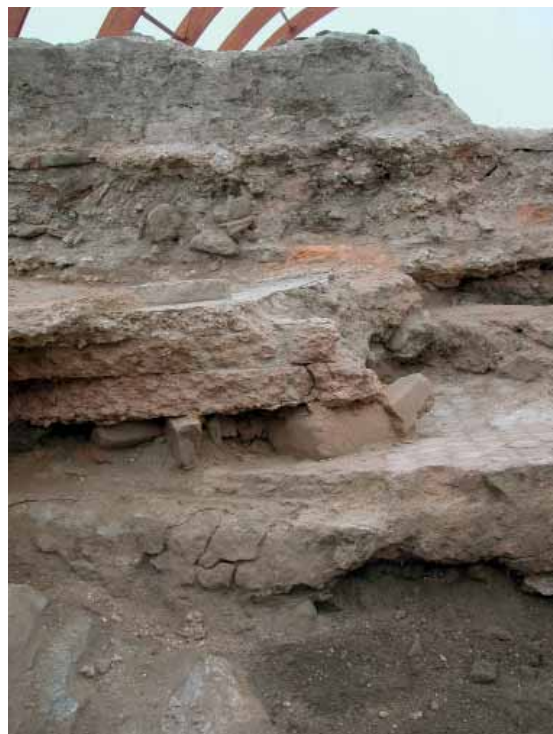
Fig. 13 Floor layers of Viminacium thermae with brick in the form of small fragments and in the form of a dust.

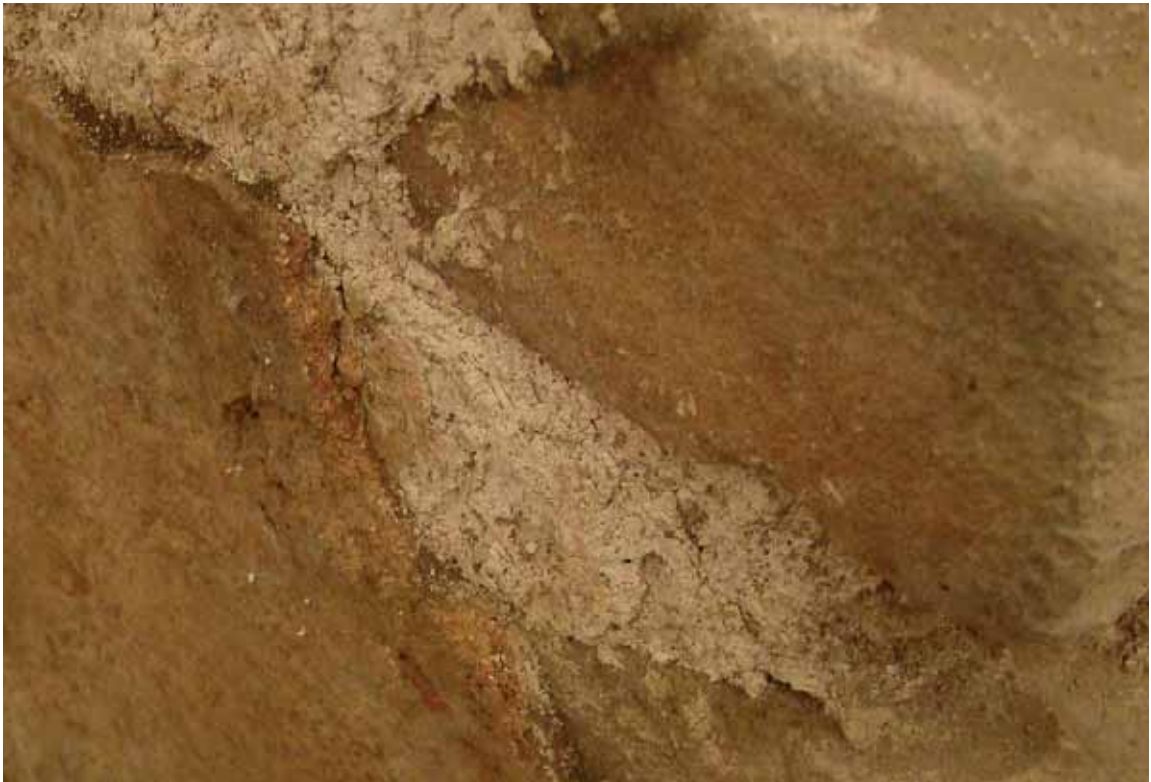
Fig. 14 Rendering layers of Viminacium thermae with brick in the form of small fragments and in the form of a dust.
Photo-documentation of Institute of Archaeology Belgrade

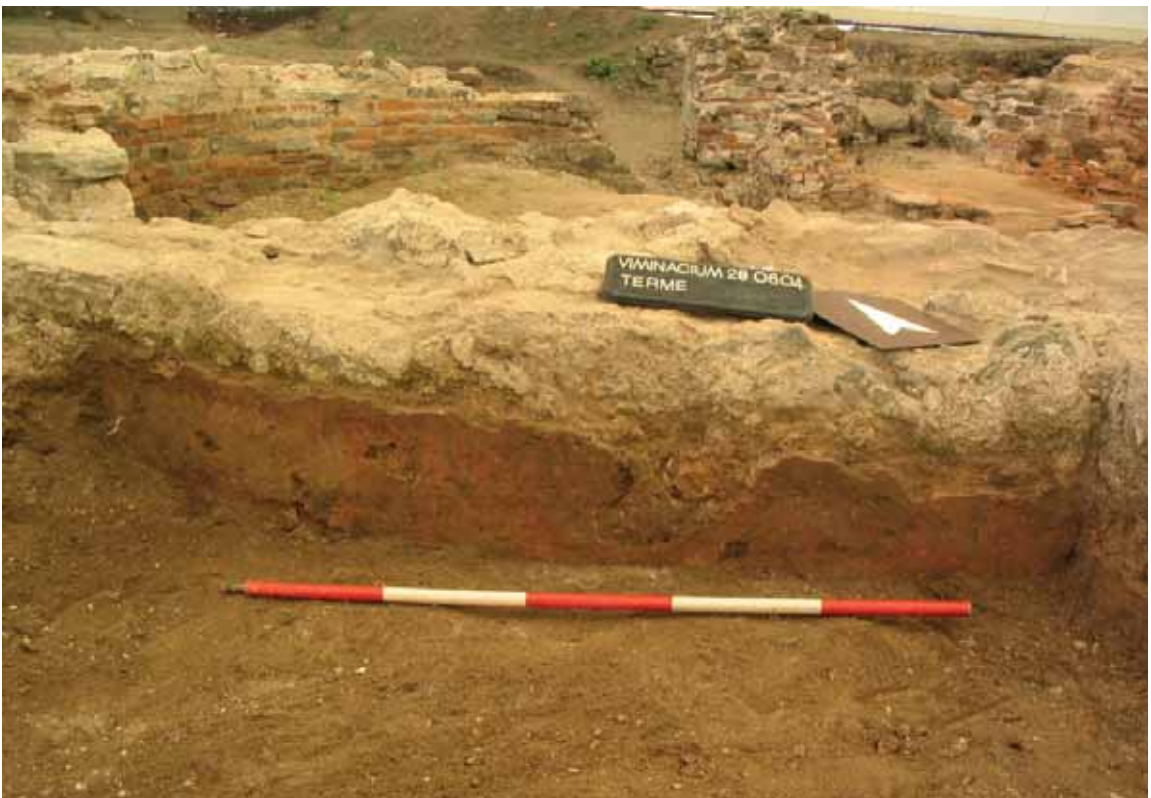
Fig. 15 Outer wall of Viminacium thermae, with red mortar having brick in its structure.
Photo-documentation of Institute of Archaeology Belgrade

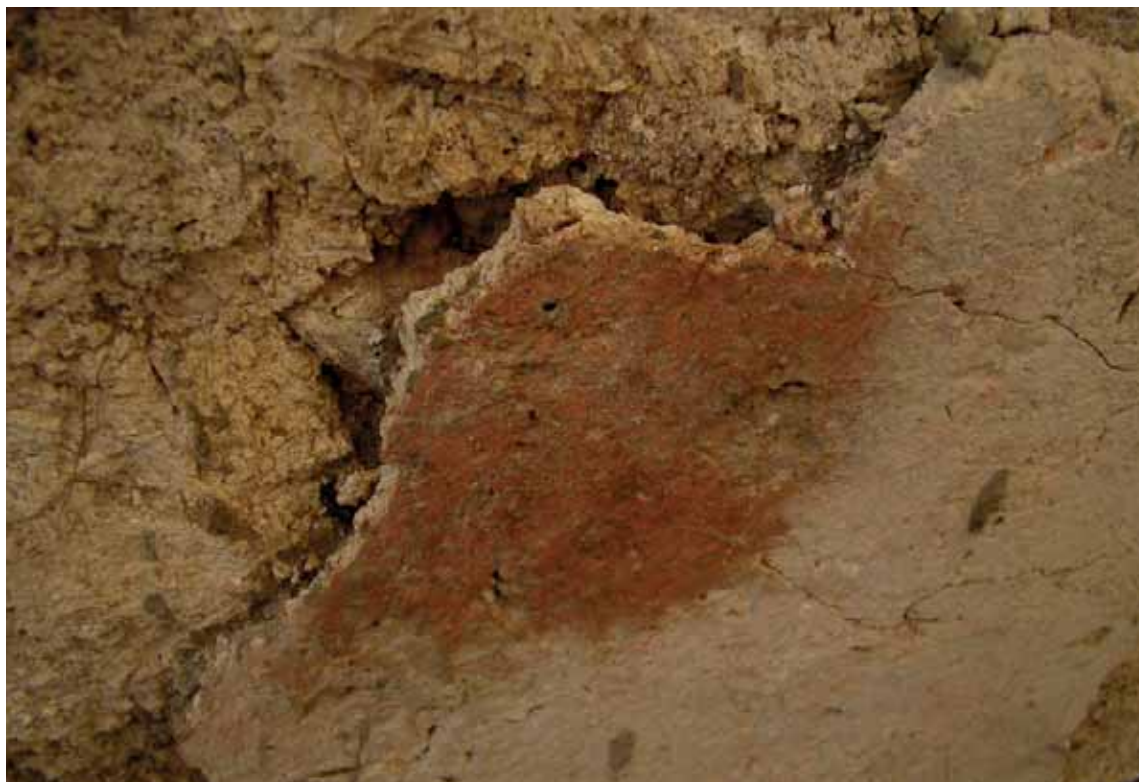
Fig. 16 Outer wall of Viminacium thermae, with red mortar having brick in its structure, detail.
Photo-documentation of Institute of Archaeology Belgrade

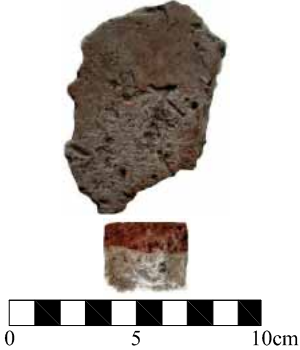
THICKNESS	1.0cm	+	1.0cm	fresco	space between II and III
		COLOUR	white		pinkish	red to orange	
		COMPOSITION	marble dust and slaked lime		brick dust and slaked lime	painted surface with no motifs	
		CONDITION	middle compactness high porosity dry vegetable fibres		middle compactness high porosity	not polished

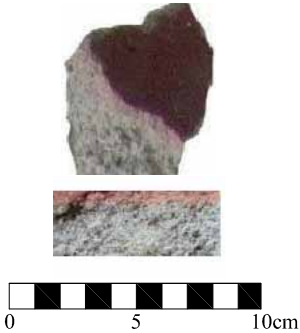
THICKNESS	3.0cm	+	0.5cm	fresco	1
		COLOUR	grey		reddish	red	
		COMPOSITION	quartz dust and slaked lime		brick dust and slaked lime	painted surface with no motifs	
		CONDITION	middle compactness high porosity		middle compactness high porosity	polished	
		PHOTO	ARRICIO	+	INTONACO	PAINTED LAYER	ROOM
GROUP 3

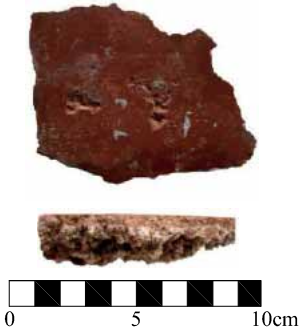
THICKNESS	1.6cm	+	0.4cm	fresco	I
		COLOUR	reddish		reddish	red	
		COMPOSITION	brick dust, brick coarse (max 1cm) and slaked lime		brick dust and slaked lime	painted surface with no motifs	
		CONDITION	low compactness high porosity		middle compactness high porosity	polished
