BOJAN POPOVIĆ  
 Institute of Archaeology  
 Belgrade, Serbia  
 E-mail: pop984@hotmail.com

## GLAMIJA - RTKOVO, NEW CONSIDERATIONS

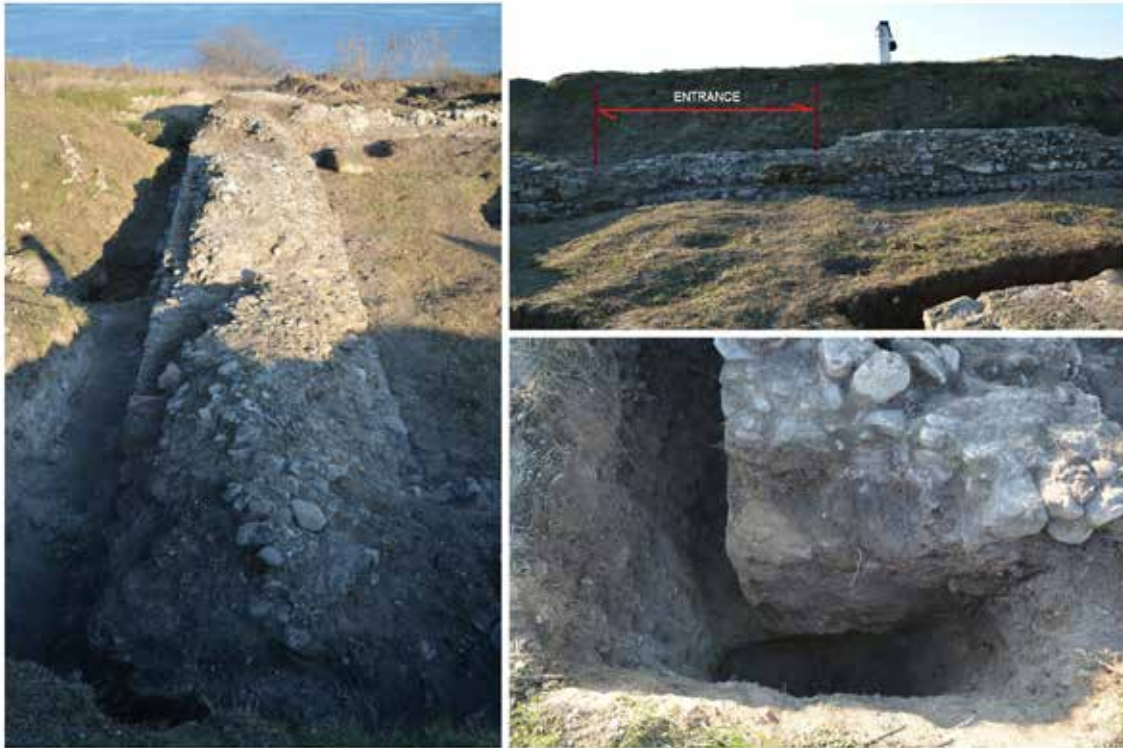
Fig. 5. Construction and masonry techniques of the foundation and above-ground zone of the rampart (photo by B. Popović)

must emphasise that no bricks with seals have been found during the excavations so far, which makes it somewhat difficult to conclude which military unit was stationed here. The entrance to this fort was most likely located on the western side. Its position is not exactly determined, but it can be assumed based on the larger stone blocks in the zone of the walls' plinth. (Fig. 5)

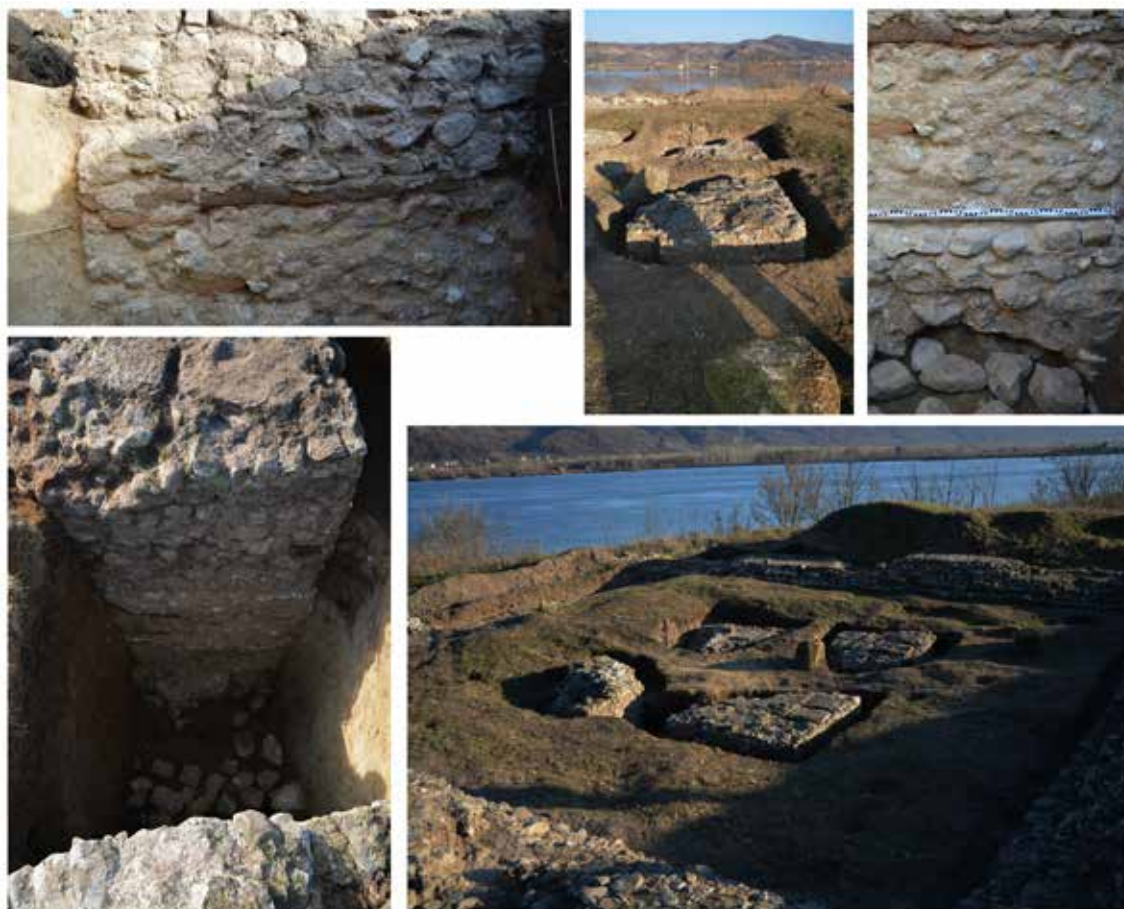
Fig. 6. Construction and masonry techniques of the foundation zone of the pillars in the interior of the fort  
(photo by B. Popović)

In the central part of the internal fortification, four foundations were discovered, built of stone and, in some places, bricks bound with lime mortar (Fig. 6). They are arranged symmetrically, and they served as support for the masonry pillars of the upper structure. The pillars have irregular square bases with one rounded corner, measuring about 2.30 m x 2.30 m, and the bottom of the foundation was found at 2.20 m from the ground level, i.e., from the level of the preserved wall mass. The distance from the pillars to the rampart is about 3.50 m, while the distance between the pillars is about 1.50 m. In the inner part of the fortification, in the north-eastern corner, a masonry structure measuring 1.10 m x 1.90 m was discovered, emerging from the mass of the wall. There is a noticeable cascading level that can be connected to the stairs, while the larger levelled surface could be characterised as a landing from which one stepped on the second stair flight at a right angle (Fig. 7).

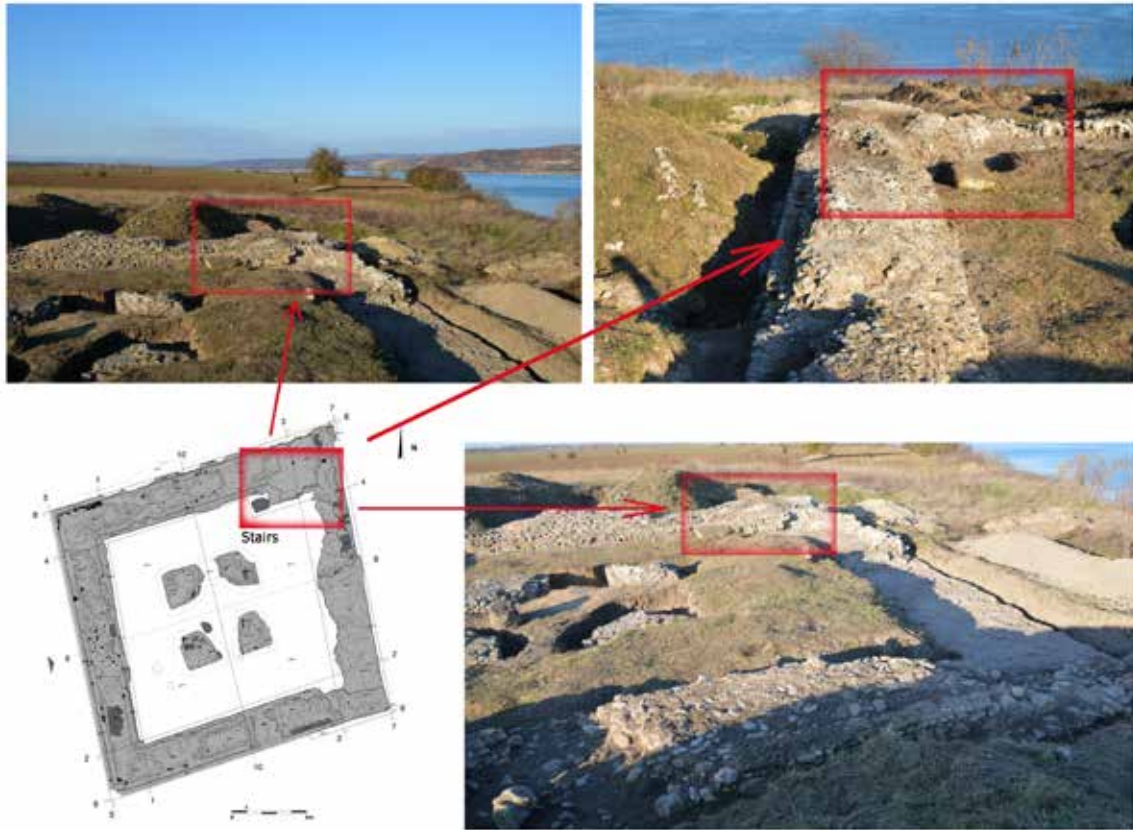
Fig. 7. Masonry structure of stairs (photo and drawing by B. Popović)

in the rubble above the floor. (Gabričević 1986: 74) Also, in support of the storey construction, there is a rectangular mass of masonry in the northeast corner of the fortification, on which the remains of three steps and a landing, from which the second flight of the stairs was accessed at a right angle, can be identified. The second flight of stairs was most likely wooden because no masonry structure was found, so such a solution is the only possible one. The first flight of three steps is parallel to the north wall and approached from the eastern side, while the second flight was probably parallel to the east wall and was approached from a masonry landing. The position of the staircase next to the rampart determines the height at the exit part of the upper floor construction, as well as the organisation and structural assembly of the upper zone. If we were to assume, based on the free space where it is possible to form a wooden flight of a staircase, the number of treads and the height of each step, we get an approximate height of about 6 m from the floor level.

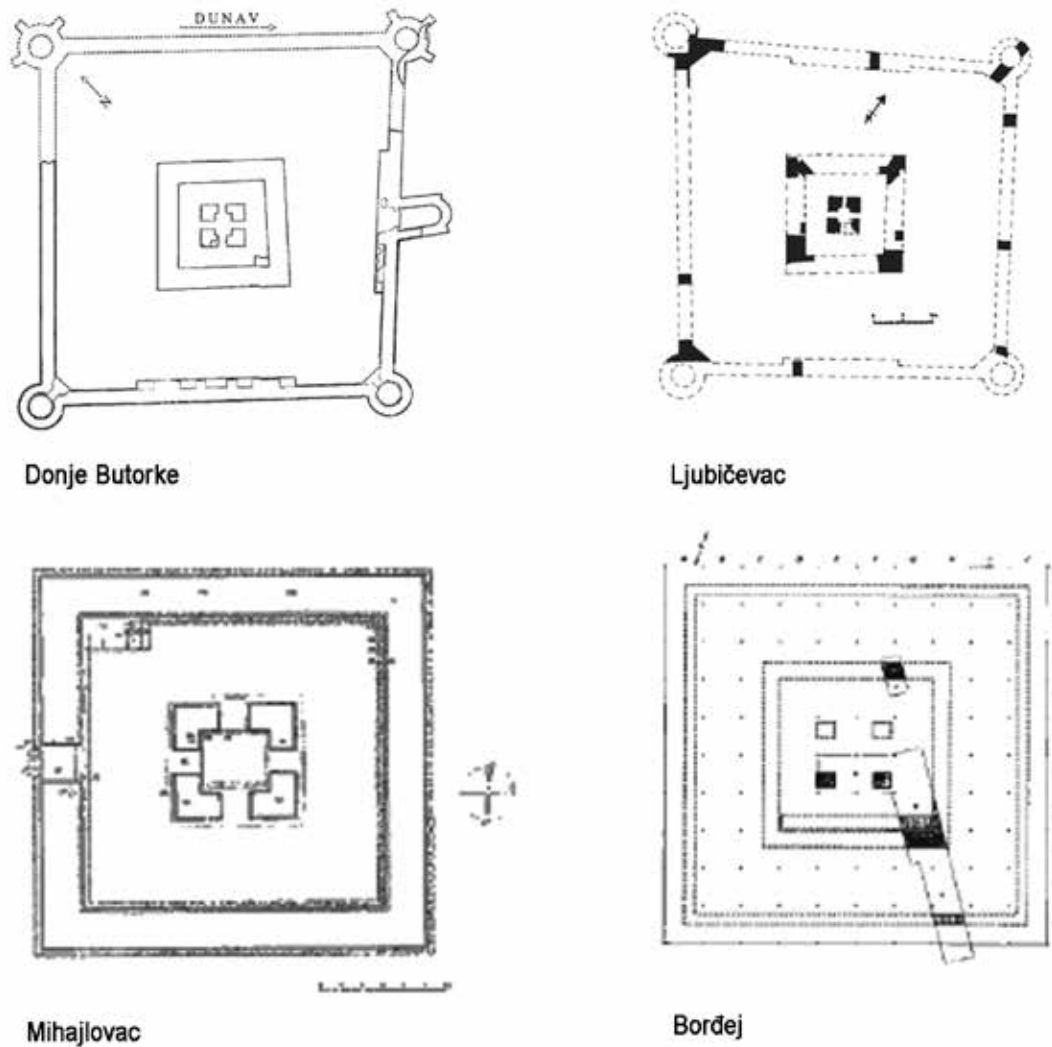
Fig. 10. Analogies - the fortifications that are most similar (according to Pop-Lazić, S. and Rumel, C., 2020)

1986: 74), but it can also be dated thus based on the masonry technique and the materials used. It is assumed that the fortification suffered some damage at the beginning of the 5th century, when it was partially rebuilt (Gabričević 1986: 72). Also, (Fig. 10) analogies with similar fortifications in the immediate vicinity, Donje Butorke, Mihaelovac, Borđej and Ljubičevac, (Цермановић-Кузмановић 1979; Цермановић-Кузмановић и Станковић 1984; Цермановић-Кузмановић и Станковић 1986; Паровић-Пешикан 1984) indicate that this fort was built during the 4th century, i.e., that there was a series of fortifications built in the period of the first tetrarchy, at the time of Diocletian. The older fortification, which is a fortification in the true sense of the word, has not been clearly dated in the literature due to the complete absence of movable finds. (Gabričević 1986: 73) We assume, based on the dimensions, masonry techniques, as well as analogies with the already mentioned fortifications of Borđej (Цермановић-Кузмановић и Станковић 1984: 217) and Donje
