MARIA STEFANIDOU

Aristotle University of Thessaloniki
School of Civil Engineering
Laboratory of Building Materials
Thessaloniki, Greece
E-mail: stefan@civil.auth.gr

THE CHALLENGE OF A SUCCESSFUL MORTAR INTERVENTION IN HISTORICAL BUILDINGS

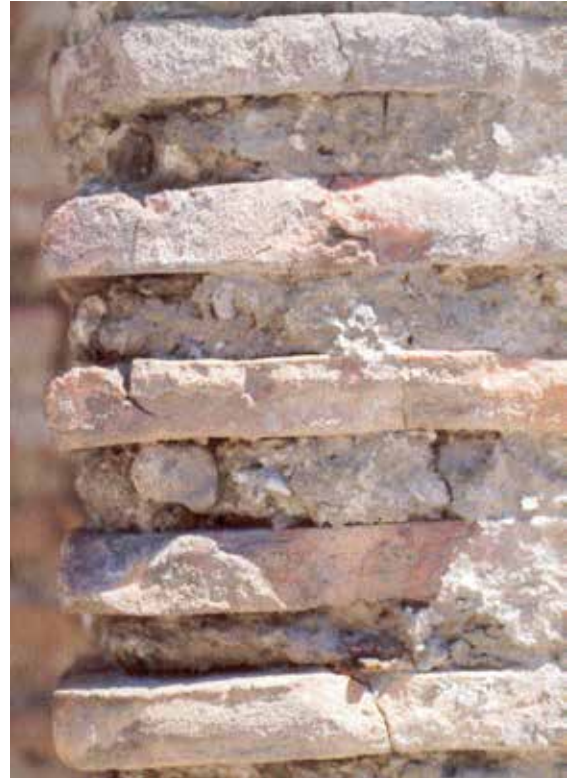
Figure 1. Historical structure of Hagia Sophia (Greece), Thessaloniki, 6th century AD (photo by the author).

Figure 1 shows some typical Byzantine masonry with thick mortar joints (the thickness of the joints is almost equal to that of the bricks). The pathology of this masonry is restricted to small cracks (in the joints but also in the bricks) while loss of material can be seen at the edges of the mortar. The dawn of the 21st century brought an acute climatic problem. In light of this, research into compatible restoration mortars incorporated new ideas based on recycling principles and circular economy. One of the problems arising is that of the repair materials that have to fulfil the criterion of compatibility with those already existing in the structure, the old building materials. Many studies have been made concerning the parameters that can be tested to produce strong, durable and compatible new repair materials.

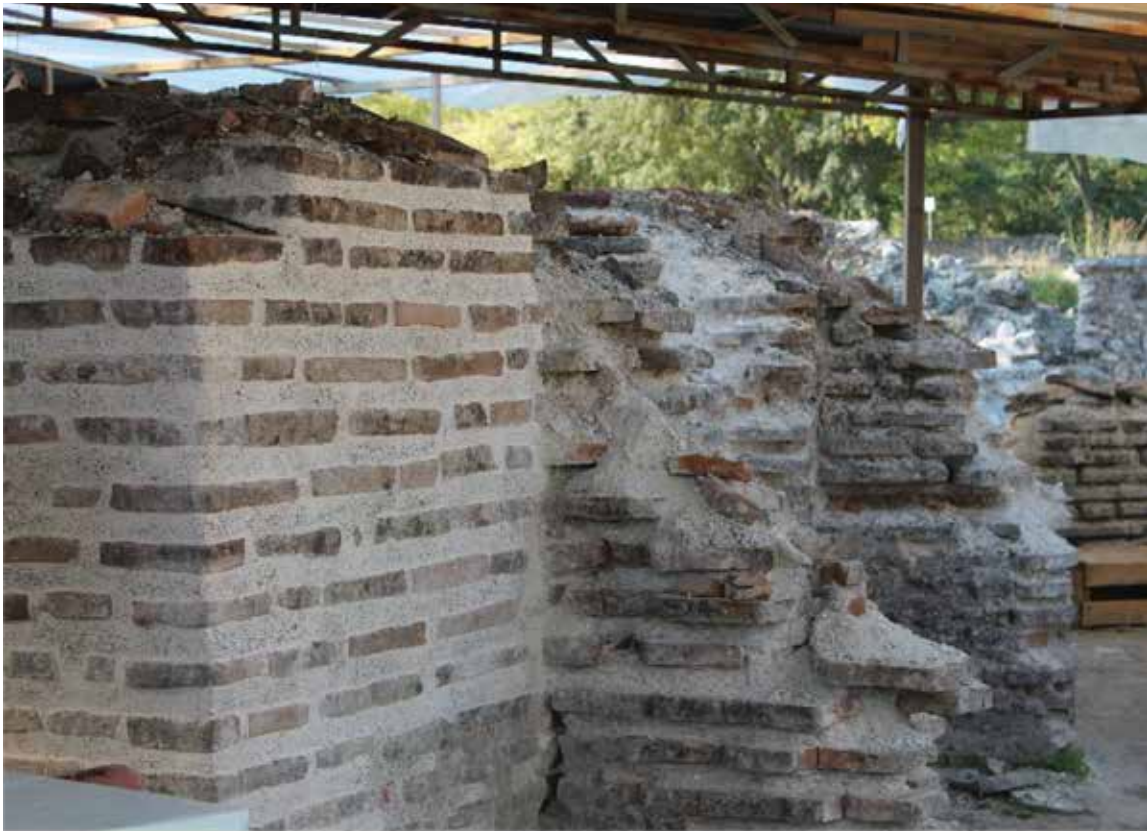
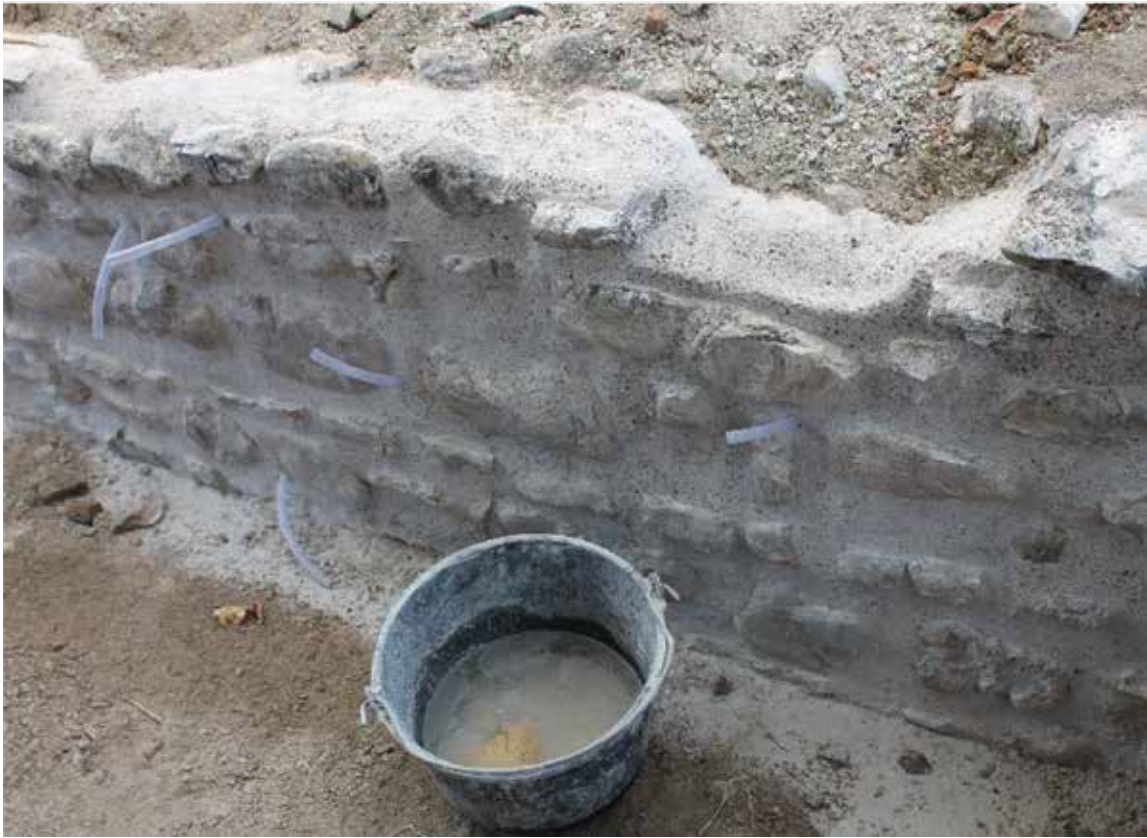
Figure 2 shows an example of a worksite at a Roman site in Dion. The application of compatible mortars based on lime and natural pozzolan

Figure 2. Restored masonry of a Roman site (Dion- Greece) (photos by the author).

(Figure 2 - top) as well as lime-based grouts to strengthen the masonry (Figure 2 - bottom) is indicated.

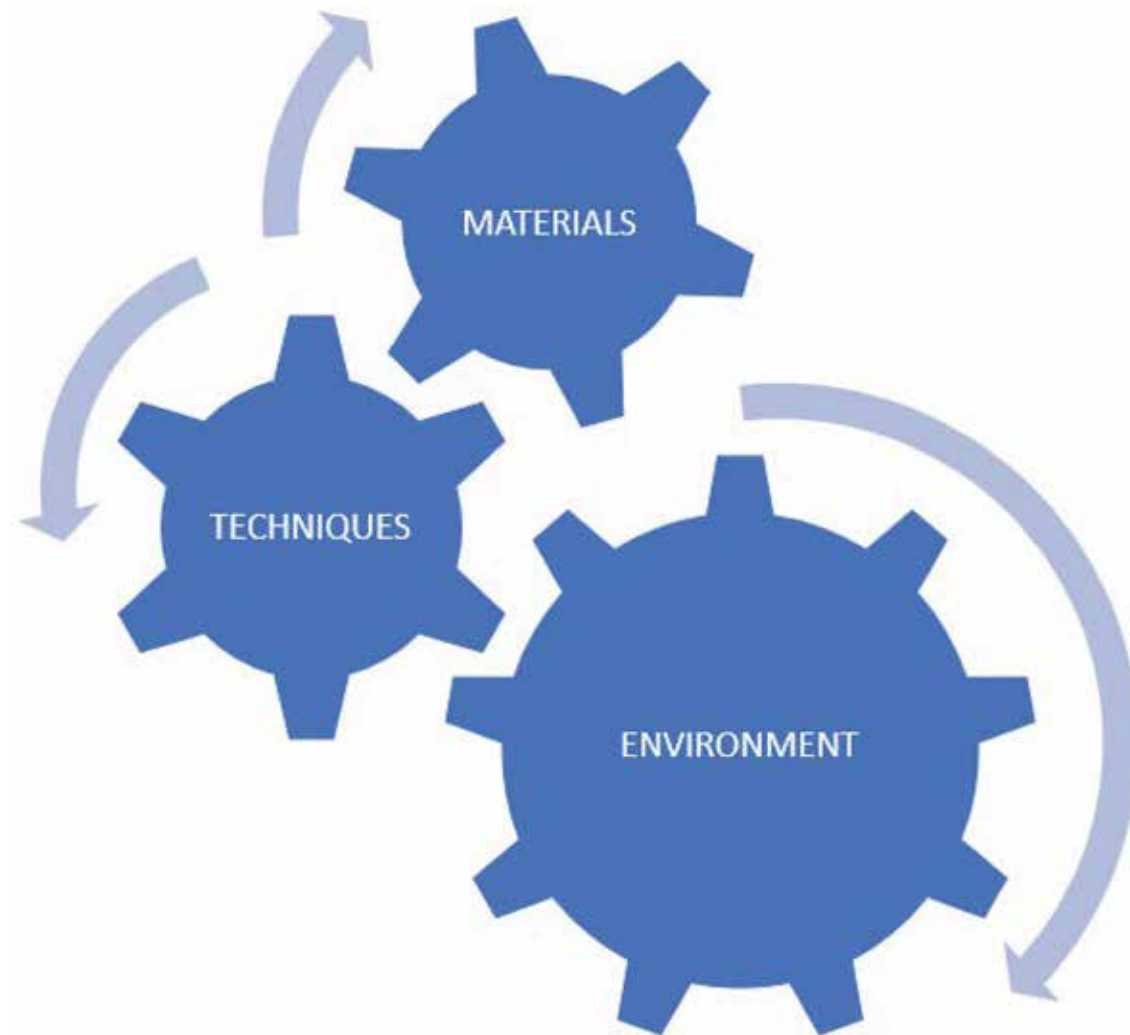
A triple helix can be considered for any intervention works and includes the design and use of repair mortars: suitable materials selected, the environment under which the structure serves and the techniques used for the material application (Figure 3).

Figure 3. Parameters under consideration for mortar intervention (scheme made by the author).

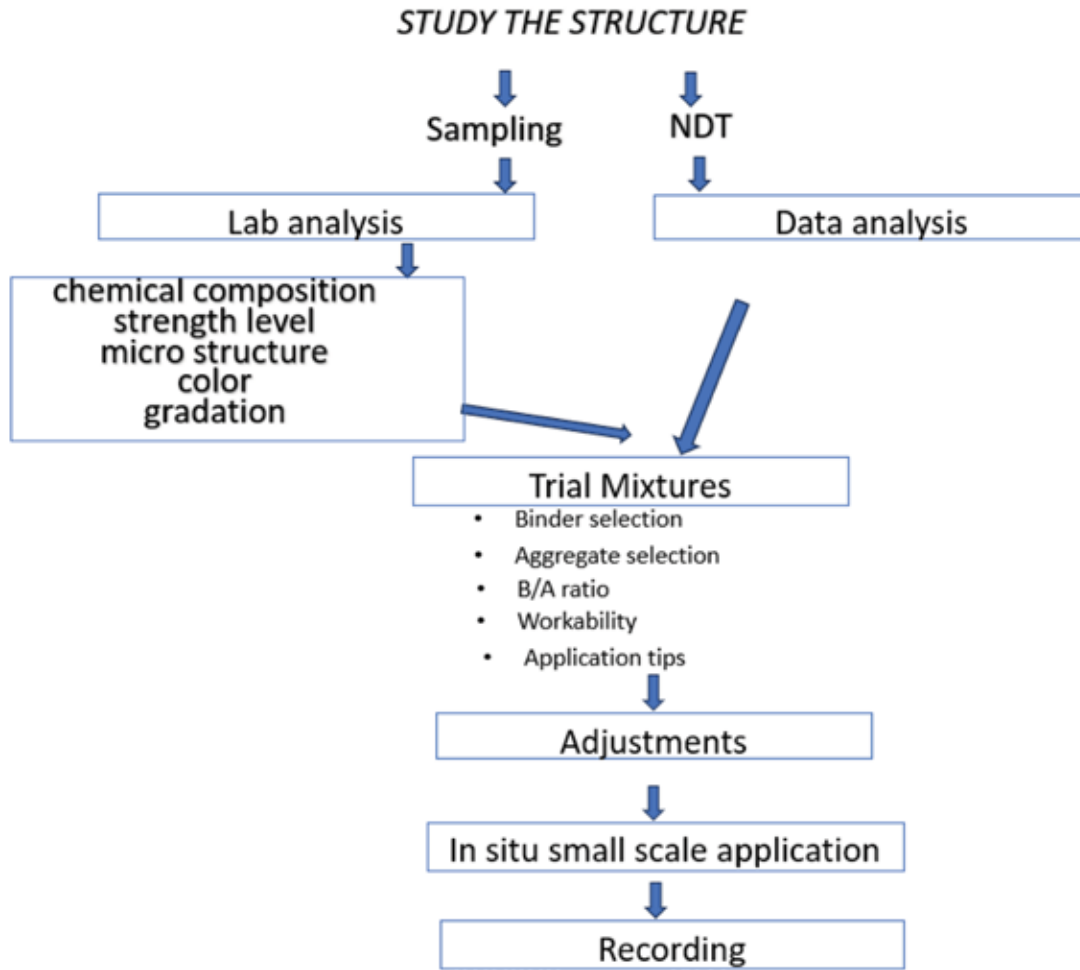
Figure 5. Schematic representation of the workflow (scheme devised by the author).

The pieces of information taken from the analysis of existing mortar (**Figure 5**) are: The type of binder; more than 40% content of CaO indicates lime mortar. An adequate quantity of reactive silica content usually implies a hydraulic component. For repair mortars, the quality of existing air lime is a significant topic that should also be taken into account (Veiga 2017: 133-136). The mineralogical origin of aggregates; their gradation and max aggregate size are parameters taken into account for the design of repair mortars. An estimation of strength level, based on site or laboratory measurements, is also a factor under consideration. Decisions are taken based on:

The suitability of raw materials is tested in terms of physical chemical and, recently, on criteria based on sustainability. Afterwards, trial mixtures are made in the laboratory and the specimens are tested. Colour, strength and porosity are measured and some durability tests are carried out if necessary (exposition in different ageing envi-

ronments) (**Figure 5**). Sometimes, a pilot application on site is suggested for in situ adaptations.
