# Žirovac landslide: a case study of the local scale landslide investigation for engineering purposes with its assessment on a regional scale

Davor Marušić

**Abstract** A detailed analysis of the “Žirovac” landslide on Croatia’s state road section in the village of Žirovac is given in this case study. The landslide was triggered by the Petrinja earthquake in December 2020 and was subject to fast-paced processes of investigation and mitigation. The engineering geological and geotechnical survey including boreholes and geophysical investigations were performed on a large local scale.

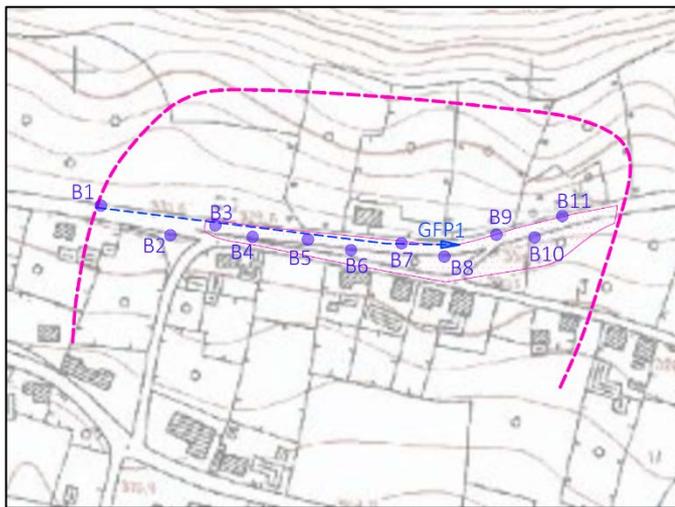
Figure 5. Review of the geotechnical research works performed on the location. Boreholes (purple dots) and geophysics (blue dashed line) within the researched landslides (magenta dashed line); topographic map source (DGU)

A more detailed review of the geotechnical research works performed on the location is given in "Tab. 1", while their position concerning the researched landslide is shown in "Fig. 5".

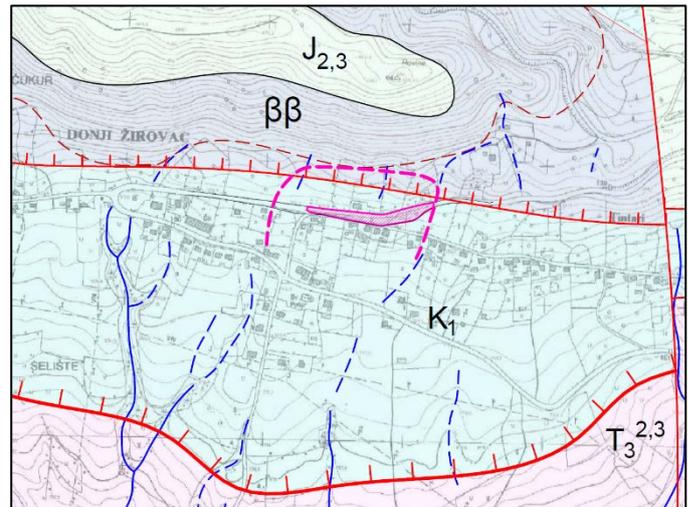
Figure 8. A review of the wider area’s structural setting and representative stratigraphical units with specific hydrogeological characteristics; topographic map source (DGU)

of secondary porosity with dominant groundwater flow. The Cretaceous sedimentary rocks within the researched landslide represent the media of generally low permeability and dominating intergranular porosity, with the possibility of forming local and irregular groundwater paths within the broken limestone layers. Consequently, in the close vicinity of the secondary thrust or at the contact of the metamorphic and Jurassic complex with the Cretaceous layers, temporary springs, and surface drainage paths are registered. Triassic dolomites further to the south also represent the media of low permeability and secondary porosity, maintaining the surface flow of the water (“Žirovac” creek).

Representative bedrock and cover on the landslide location are characterized by a high variety in permeability, where the gravel-dominated cover and limestone bedrock represent the permeable media, while the clay-based cover and bedrock represent the impermeable media as shown in “Tab. 5”.
