Geotechnical Conditions, Stability Analysis and Remedial Measures of Višnjička 74 Landslide in Belgrade

Abstract This paper presents the results of geotechnical investigations, stability analysis and urgent remedial measures of the landslide at Višnjička 74 street in Belgrade. The area under study is located at the foot of an old fossil landslide. The landslide was activated due to excavation of the foundation pit in June 2023. Due to large displacements of the retaining structures and the surrounding objects, urgent remedial measures were proposed. Following these measures, further sliding was prevented. Additional geotechnical investigations were performed (geophysical investigations, inclinometer measurements, boreholes, soil sampling, laboratory tests, piezometers), to obtain more comprehensive insight into the processes responsible for sliding. Residual shear parameters were determined by laboratory tests, and back calculated using numerical analysis and inclinometer readings. Very complex geotechnical conditions were determined on-site and thus presented in the light of future construction works.

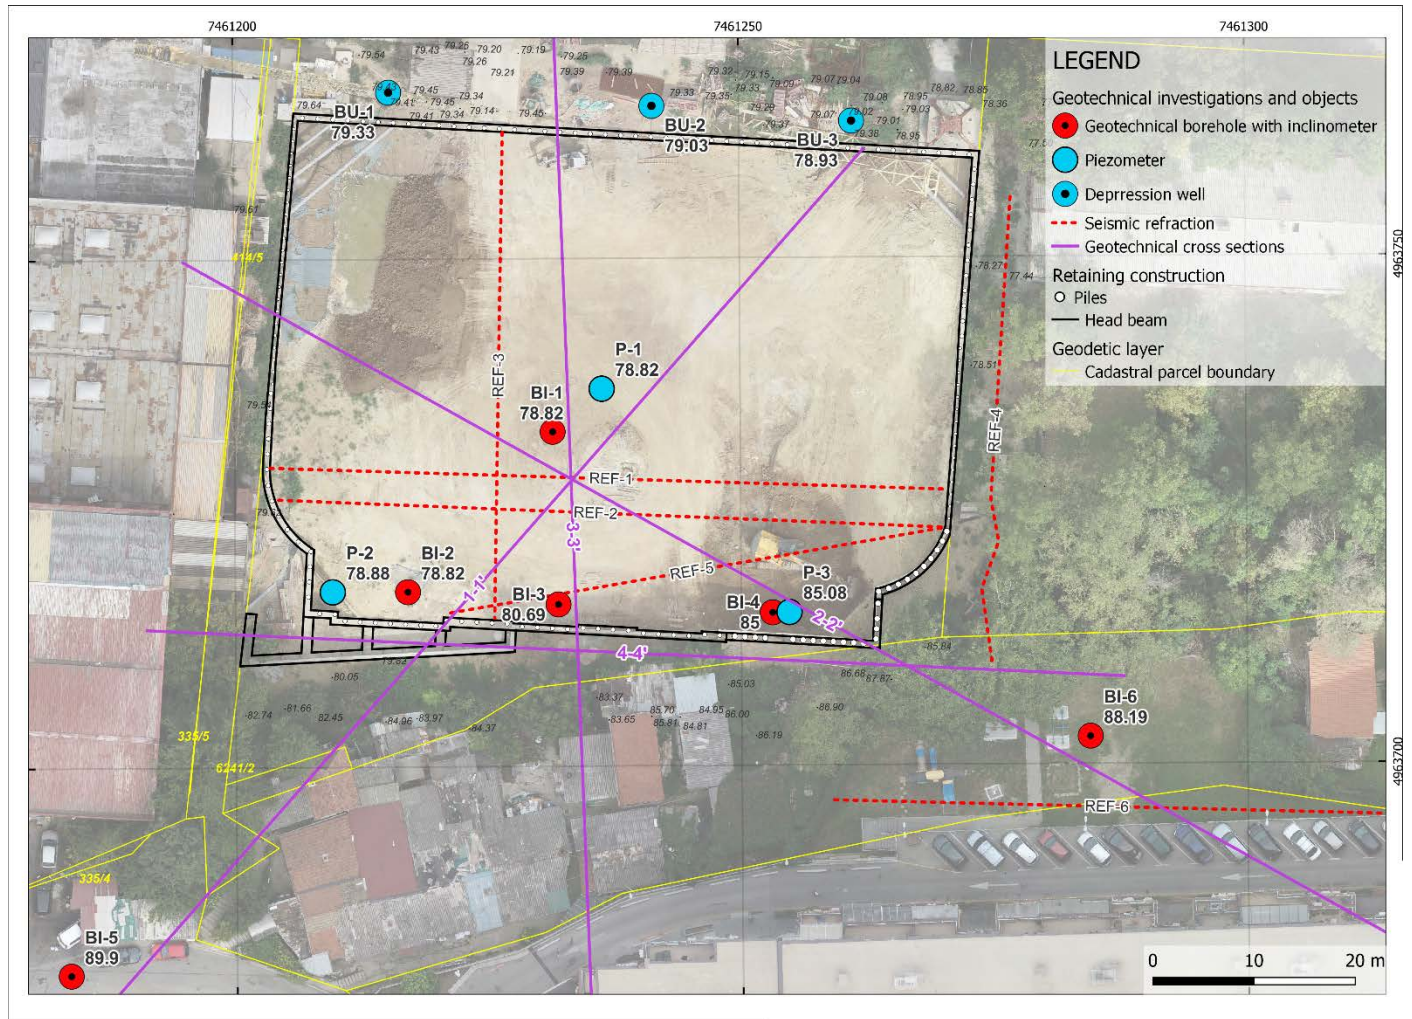
Figure 2. Situation of newly conducted geotechnical investigations

The following engineering-geological and geotechnical investigations and tests were carried out in the research area (Figure 2):

The borehole drilling was conducted using continuous coring to investigate subsurface geology, sediment properties, and hydrogeological characteristics. Six new boreholes, reaching depths of up to 36 meters (totalling 186.9 meters), supplemented previous investigations. Special attention was given to obtaining undisturbed core samples to identify potential landslide slip surface zones by reducing the drilling pressure and without using additional fluids. Detailed engineering-geological core logging aided in defining geological layers, while core samples were tested in geotechnical labs to determine soil physical and mechanical properties. Piezometers were drilled and installed close to the borehole positions to monitor groundwater levels and assess their influence on terrain deformation and nearby structures. Besides the piezometers, existing depression wells were also used for this purpose (Figure 2).

Geophysical investigations were undertaken at the site by seismic refraction profiling along six profiles (Figure 2). Their positions and lengths were customized based on site conditions. The aim was to identify geological layers with varying primary seismic wave velocities, that could indicate diverse lithological environments, and to ascertain the presence of a solid rock mass. Across 5 of 6 profiles, four different layers were identified, with three boundaries that delineate them. Despite the efforts, the presence of a solid rock mass within the investigation area could not be confirmed. The south-eastern border zone with a piled retaining structure including the RC pile cap disabled its confirmation. Contour maps of identified geological unit borders were generated to determine spatial positioning and quantify angle variations, crucial for assessing potential instability or slip surface zone.
